DYEHOUSE AT BRIMSCOMBE MILL

MICHAEL POUNTNEY

STRUCTURAL APPRAISAL by Geoffrey Beddow ACIM., FCSI.

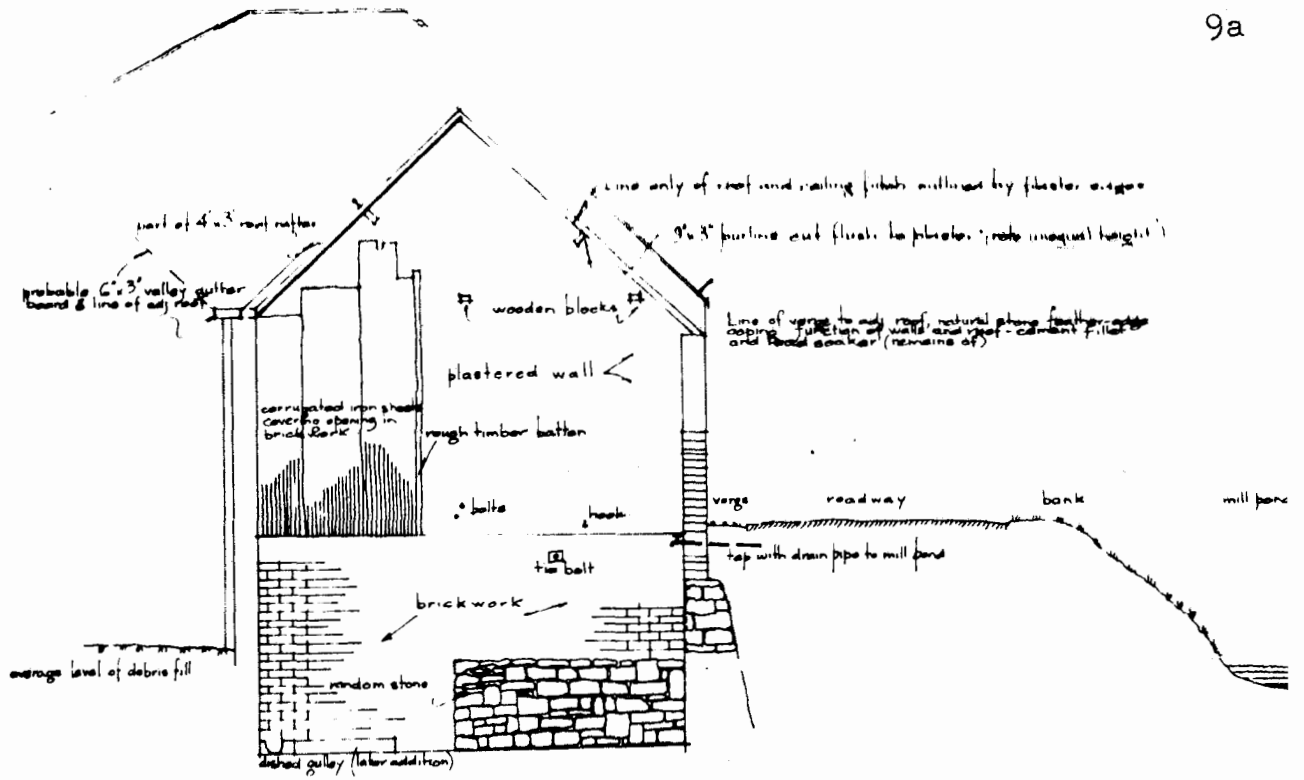
SECTION 1.

Traces of pen stock framings were discovered in the millpond, aligning with the flap inlet valves to the troughs. It is feasible to assume these were controlling the supply of water to the dyehouse but indicate the water level, when they were in use, to have been some 4' 0" (approx) lower than at present (see section of Survey drawing). No penstock machinery remains.

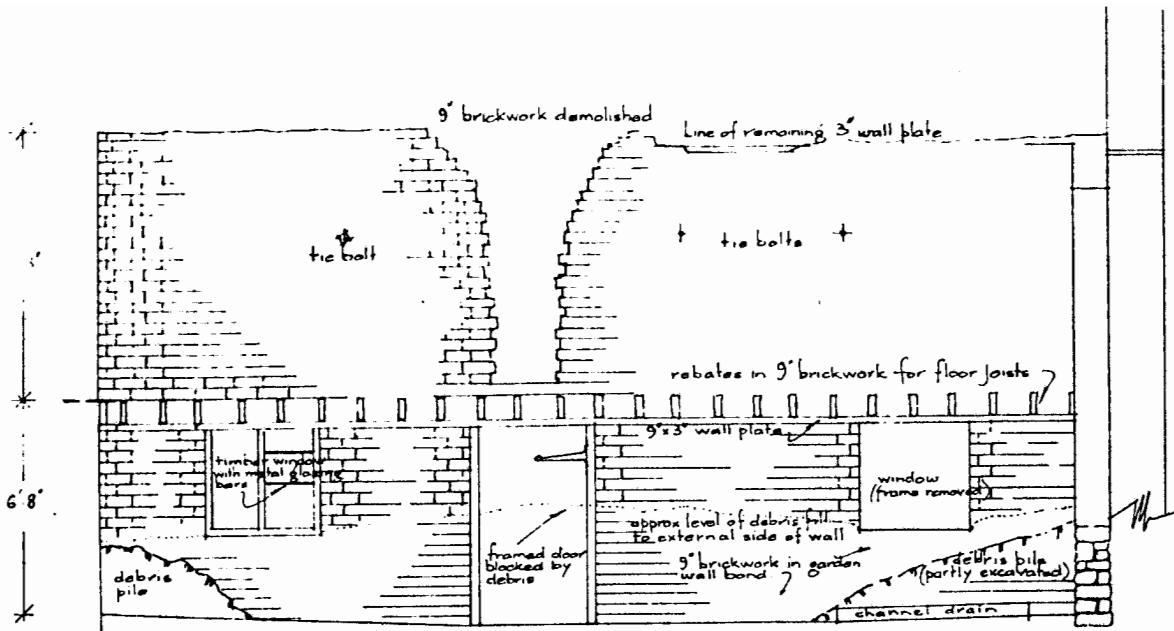
INTERNAL SOUTH WEST ELEVATION.

Externally on the South West elevation ("new" brick walling), traces of an added structure with a pitched roof was discovered occupying this area from the East partition wall to the lower level doorway. It is possible this structure extended the full length of this wall as wall tie bolts still remain in the upper areas of the brickwork, either side of the doorway, whilst one tie rod to the roof extension truss is still, in part, in situ. Measurement and calculation indicate this extension to have been about 16' 0" wide thus enclosing part of the original adjoining construction to the West end where its wing returned Southward. The whole of this area has been backfilled above cill level of the lower timber and metal windows of the dyehouse to a depth (av.) of 4' 6" and semi-consolidated.

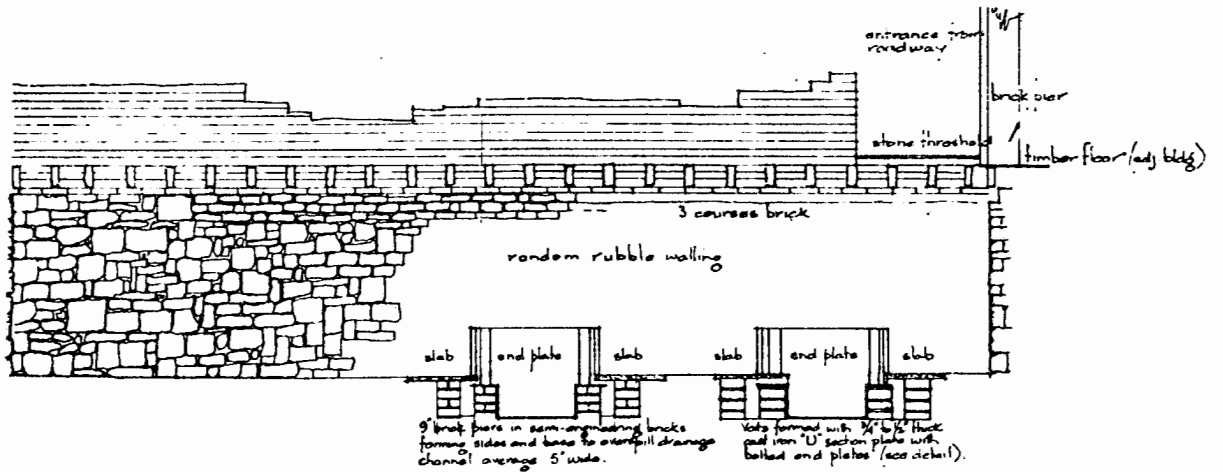
INTERNAL NORTH EAST ELEVATION.

At the present tarmacadam level, a slate threshold indicates the later entrance door to the 'new' timber floor, formed through the 'new' solid garden wall bond brickwork with 18" X 4½" integral piers carrying the roof trusses. Within the bays thus formed, early type cast iron small light window frames in wood surrounds were built in. No trace remains in the central dyehouse, the walls being demolished to under sill height, but they are in situ in the building immediately to the west. The roof levels were staggered on the three buildings forming the dyehouse range, rising some 4 and 6 brick courses at each party wall from East up to West, whilst on the West party wall of the dyehouse under review, a curious configuration of the brick party wall, capped with Cotswold stone saddleback coping stones, has no obvious relevance to constructional requirements. The gable ends at the far East and West of the range are conventional.

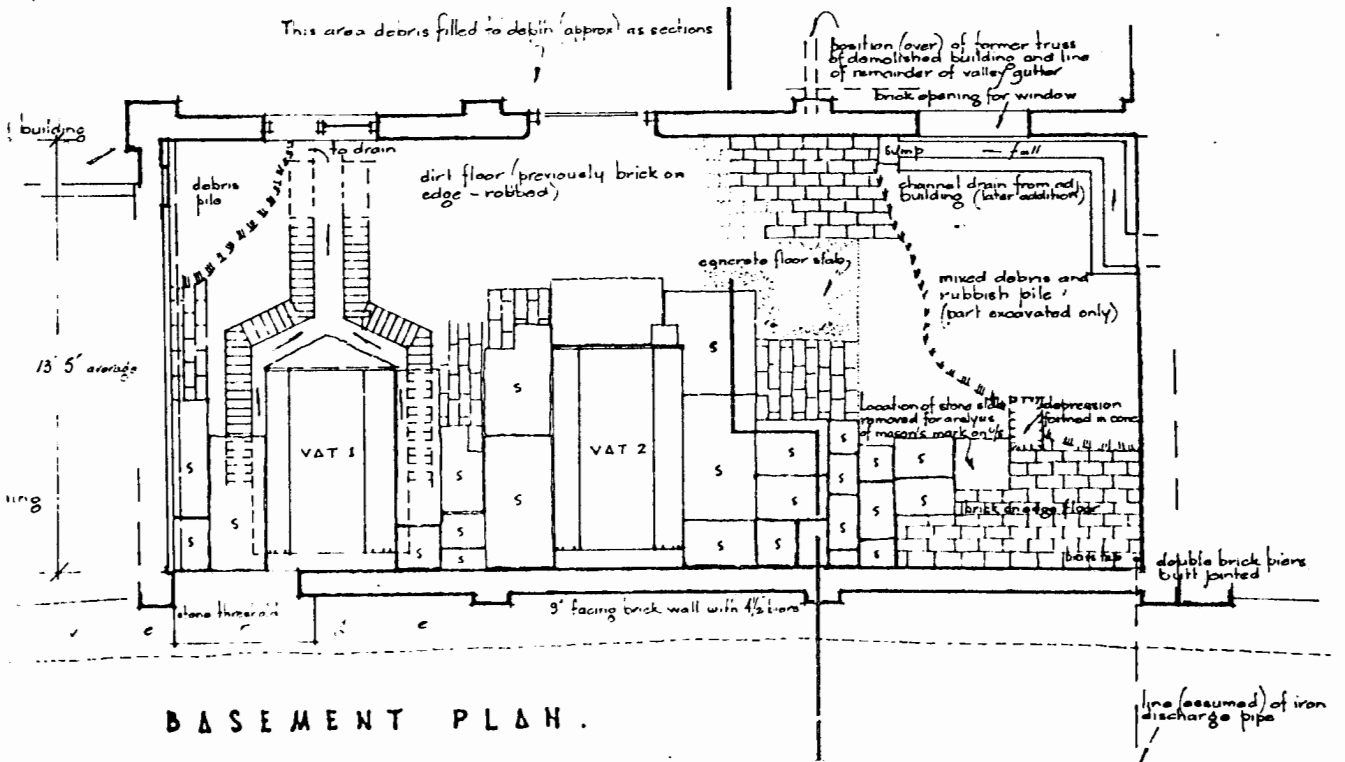
BASEMENT PLAN.

The two troughs occupied only half of the length of the room, as can be seen from the plan. At the other end, stone flags and drainage gutters indicated more use of water, though no remains of any installation were visible. There was nothing specific to indicate a boiler in this particular room, and the roof does not appear to have possessed the louvres of the large dyehouses adjacent.

The floor was laid to a pronounced fall from N.E. to S.W. and with a slight crossfall to ensure drainage of the washing water to the open "Y" culverts connecting to a still functioning enclosed drain in the S.E. corner of the building. Some (earlier) brick lining of the culvert is evident but this is not associated with, in type, the bricks used for general rebuilding purposes, and for repairing the floor where slabs, for some reason have been removed.
