STROUDWATER CANAL CRANES (PART TWO)

THE DUDBRIDGE CRANE

Ray Wilson

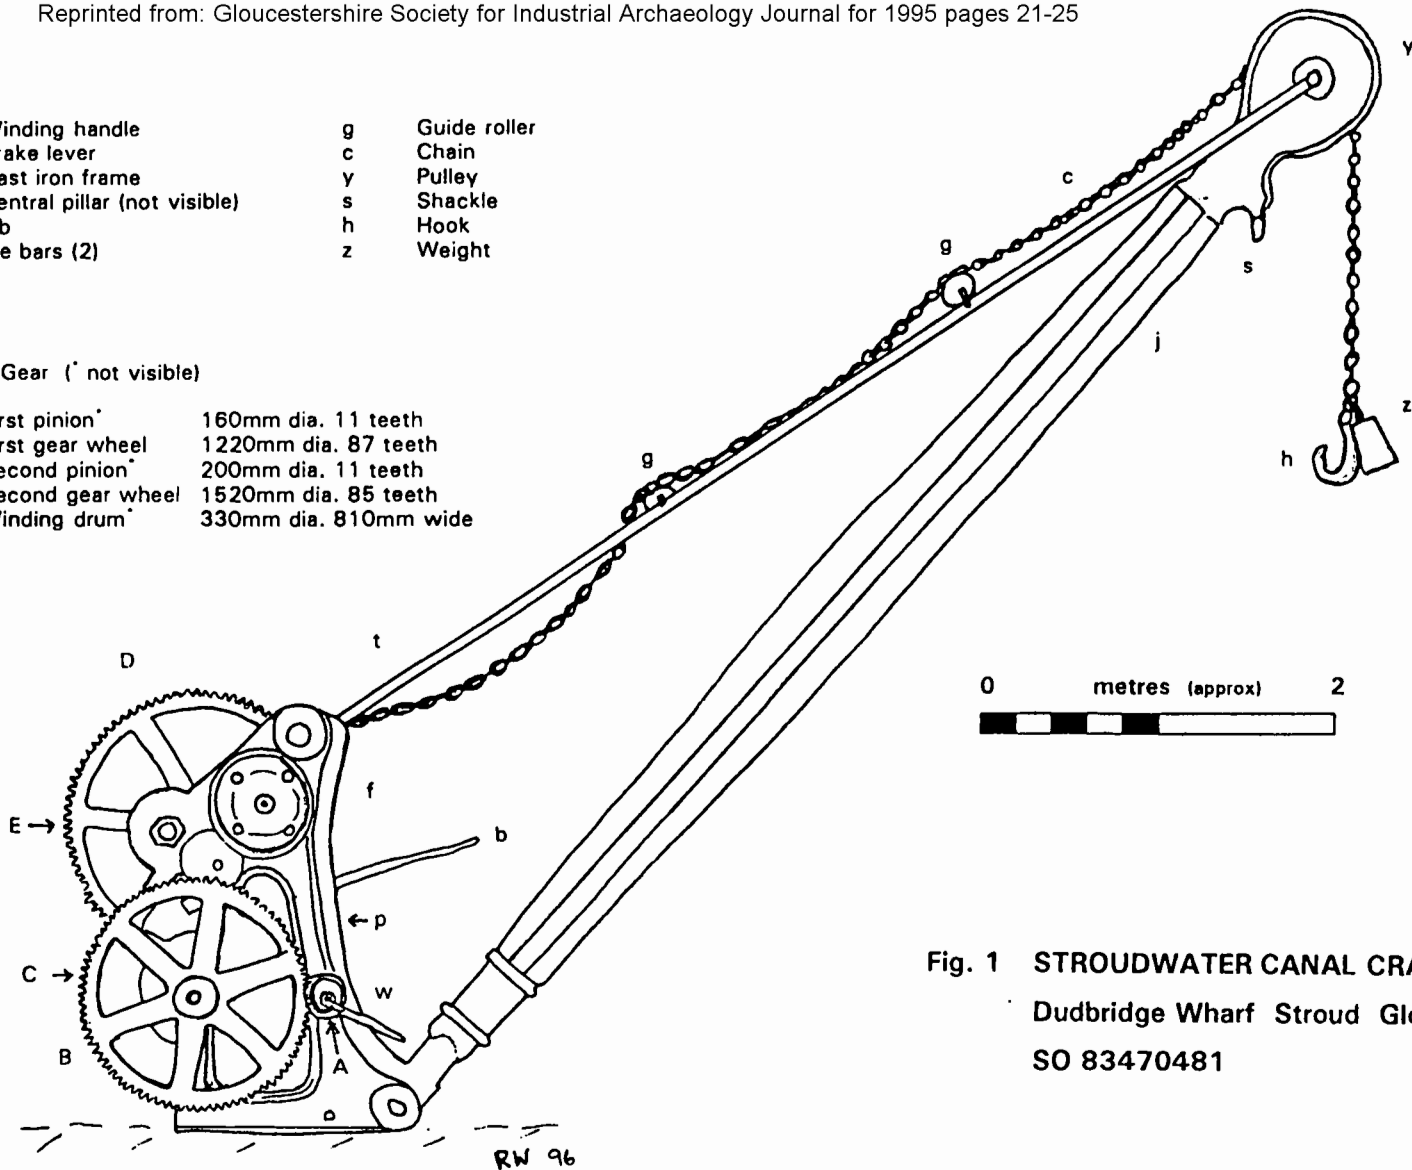
Fig. 1 STROUDWATER CANAL CRANE
 Dudbridge Wharf Stroud Glos.
 SO 83470481

The crane (Figure 1) is mainly of cast and wrought iron construction with a wooden jib. It is hand operated, non-luffing (fixed jib angle), but can be slewed (rotated). The

The crane has a fixed vertical central pillar attached to some form of base plate which is set in the ground. At present a thick layer of mud over the base plate prevents examination of the nature of this fixing. It is believed it must rest on a substantial buried foundation. The central pillar is tapered and has a maximum diameter of 530mm decreasing to 355mm at the top. The frame carrying the jib consists of a pair of side plates connected by cross members. The overall dimensions of the frame are approximately 2.4m in height by 1.5m by 1.5m. A number of wheels or rollers are fitted to the frame and run on suitable tracks on the central pillar and baseplate. These support the crane and resist the tendency for it to tilt when loaded and yet still permit the crane to be rotated.

The two main castings of the frame (the sides) bear the makers name JOHN STEVENSON CANAL FOUNDRY PRESTON. They are joined (from the top downwards) by the chain guide, the casting containing the "cap" that sits on the central pillar and takes the vertical load, the winding drum assembly for the chain and two drive shafts. A cross casting at the base carries one of the supporting wheels and three rollers. The other support roller is fixed to the winding drum assembly and runs on the central pillar near the top of the pillar which has a special profile to accommodate it. All the nuts are hexagonal and the thread forms may be Whitworth.

The jib is 7.3m in length and is inclined at an angle of 47° to the horizontal giving a top hook height of 5.4m and a working radius of 4.9m. It is probably made of pine and is an irregular octagon in section. The maximum diameter of the jib is about 0.44m and it tapers towards each end. Each end of the jib fits into a cast iron socket. The lower socket is fixed to the frame by pin joints and the upper socket casting is extended to carry the top pulley. The latter is unusual in that it is not an open pulley, but closed in across the flanges for the most part with two slots to accommodate the chain. A shackle is fitted to the head of the jib. An iron weight about 20kg is attached to the chain above the hook to pull the hook down against the resistance of the chain.

A pair of wrought iron bars connect the axle of the pulley to the top of the frame and are each about 50mm in diameter. They support two cast iron guide rollers for the chain. Loads are lifted by rotating the square ended shaft which projects from both sides of the frame. A pinion (A) on this shaft engages in the large gear wheel (B) which is mounted on the same shaft as the second pinion (C). The latter drives the largest gear wheel (D) which is attached to the winding drum (E). The

velocity ratio of the system is estimated to be about 175:1. The pinion (A) can be disengaged by lifting a retaining latch and sliding the shaft 100mm axially. The unloaded crane could be wound much more quickly using the handle on the square ended shaft of (B) rather than that of (A). In principle, it should not have been necessary to disengage pinion (A) to perform the faster winding but it is understood that it was common practice on winding gear of this type to do so. Indeed, if this was not done (A) would rotate quite fast and might be dangerous. Guards are in fact fitted where (A) engages the gear wheel (B) and between (C/D) but they appear to have been added later.

The brake wheel is 600mm in diameter and 90mm wide with a 25mm flange. Wooden brake blocks 25 x 76mm are each attached to the wrought iron brake band by a pair of nails. The brake lever can be latched to secure the brake in the off position. It appears it would need to be held on in use. The brake could then be released slowly to give good control when lowering the load. There is no apparent handle or lever for slewing the crane which was probably done by pushing on the jib.

The crane has obviously not been painted for some years and there are small flakes of rust on all iron components. However, there does not appear to be any significant loss of metal section. There are a few places, for example on the drum, where some pockmarks have occurred. It is presumed that this is a result of water ingress in minor casting faults such as blowholes. It is likely that the frame was originally painted but it is not obvious that any paint now remains from then or any subsequent re-painting. Clearly it would require a large amount of wire brushing and rust treatment to prepare properly the ironwork for painting. Some parts are very inaccessible and some dismantling would be required.

One part of the inside of the frame shows more rusting and is bright orange colour. This region should be investigated and given appropriate treatment. Advice will be sought on conservation of the ironwork as a whole, but the most appropriate treatment would appear to be to leave it in its present state apart from the small area mentioned above.

The timber of the jib appears reasonably sound although the upper side of the jib shows some flaking. The underside shows the remains of a now matt black paint or tar treatment. It is understood that it has been treated with some form of timber preservative over the years. It would seem appropriate to apply a modern timber preservative paying particular attention to the upper side. If the jib is to be painted in the future the flaking timber would have to be removed or the cavities

Most at risk are the baseplate and lower part of the frame which are submerged in the silt. It is intended to clear the silt so that these parts can be examined and recorded. At present, yard water runs into the base of the crane depositing silt and this water will need to be diverted. The winding gear and other moving parts will be greased and it is hoped that the crane will be movable again.

filled, as it would not be sensible to paint over it. At present it would appear that the colour should be black. Old photographs might show an earlier colour scheme. Alternate black and white on the eight sides might have been used.
