LEONARD STANLEY TANNERY

A Preliminary Report

Stephen Mills

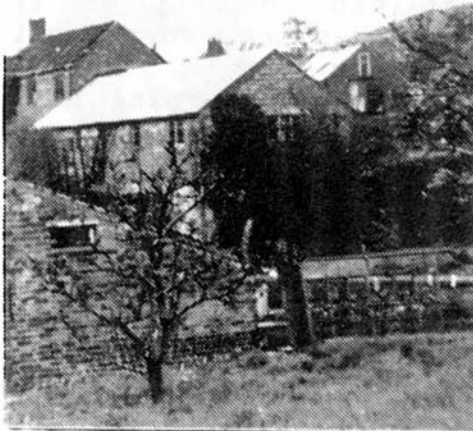
The main tannery buildings

Note the overshoot waterwheel and the drying sheds behind.

The external water wheel is of the overshot variety and is of 13ft diameter and 3 ft width. It was apparently brought from a mill in the west country and installed second-hand (16) although it apparently did not operate as the owner intended. It appears that the wheel's diameter was too great for the

available fall of water and consequently suffered problems of back-watering. It is likely that the height of the mill pond was raised at the time of installation as concrete and other constructional material used in the pond's wall show similarities.

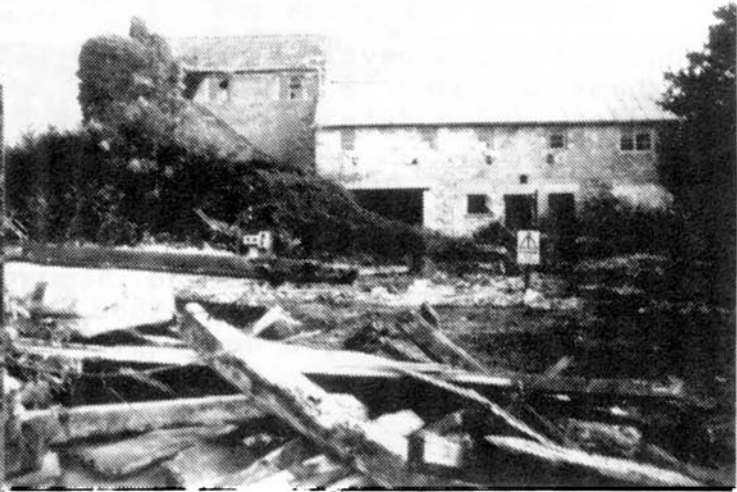
Part way through the demolition. The machinery was in the lower floor of the stone-built building. The wheel is on the extreme right.

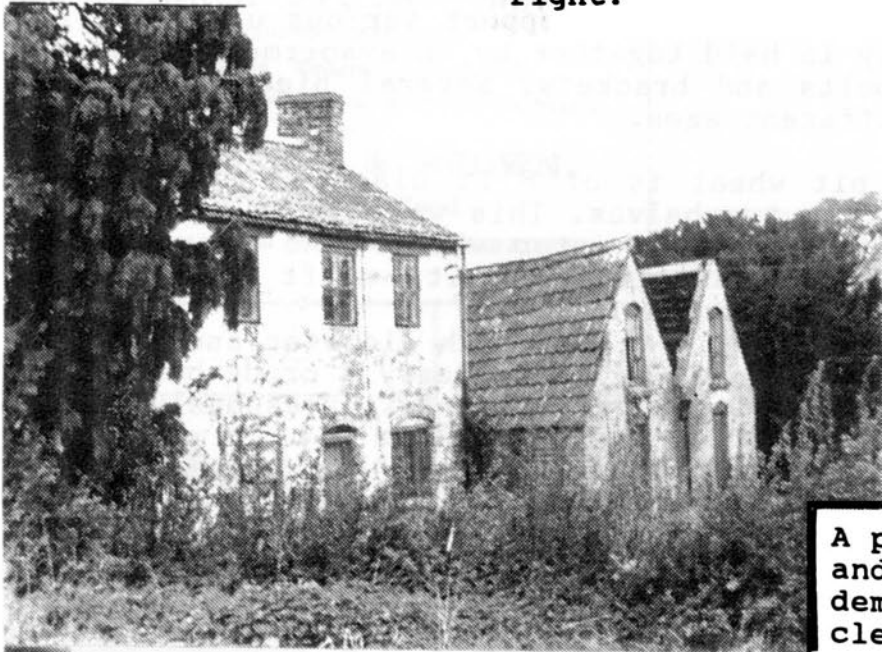
A pair of workers cottages and derelict tanning sheds, demolished early in the site clearance.

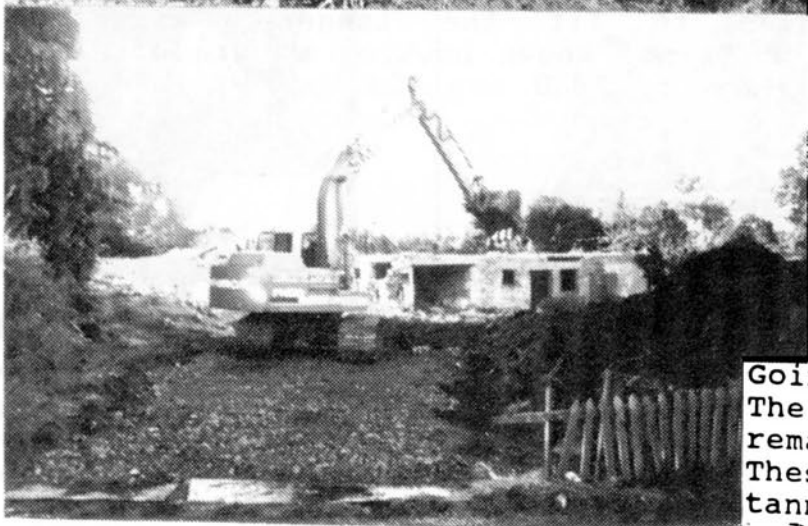
Going, going....
The large heap is the excavated remains of the tanning pits. These contained deep layers of tanning residues.

At the time of demolition, various other items of interest dotted the site, ranging from oak-lined tanning pits (destroyed at the start of the site clearance), to pumps and various small leather-working machines. Fortunately, some of these have been removed to Stroud Museum, although most were damaged. At the time of writing, it is hoped that further archaeological investigations of this important and interesting site will be carried out although it is to be regretted that access, and consequently, a thorough survey, prior to demolition was denied. As a result, a site of national importance has been all-but obliterated. Sadly, the earlier efforts of a number of individuals to protect the site came to nothing, and it is a matter of great regret that Gloucestershire has now lost its last remaining water-powered "village" tannery.
