BEARDS MILL AND THE MENDER'S SHOP (LEONARD STANLEY)

Stephen Mills

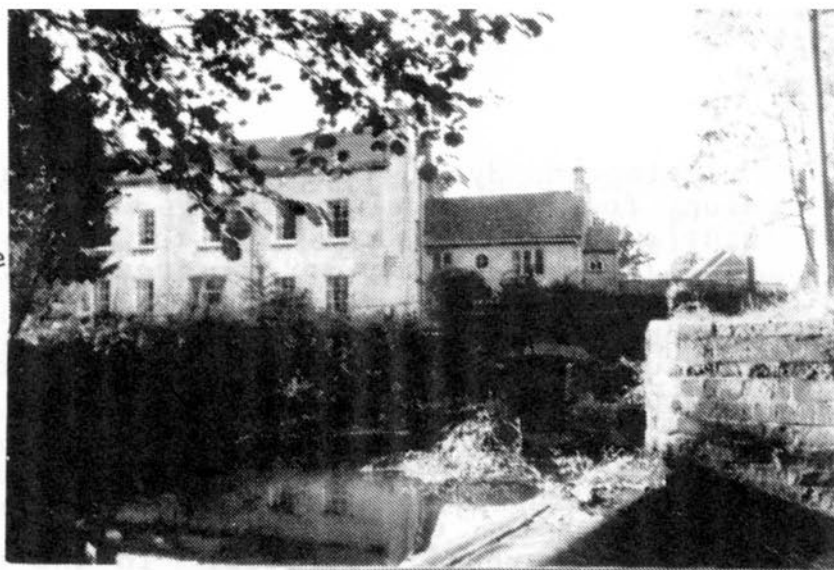
The mill house, weir and inlet to the water wheel. The main mill stood to the right of the house.

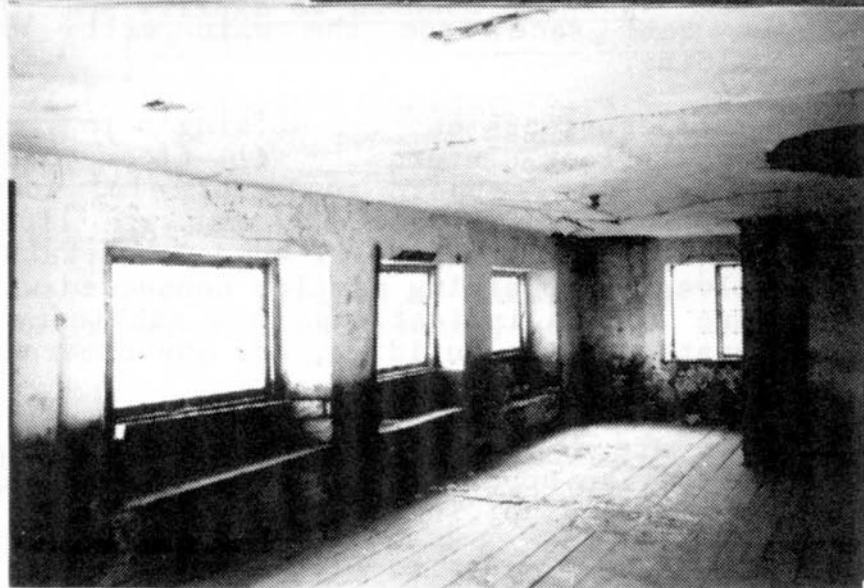
The interior of the upper floor

The upper floors consist of single long, rectangular rooms, one on each floor. Internally, all floor joists, boards, skirtings, timbers, etc. appear to be of elm, some of it in very poor condition. The window recesses are lined with wood and each show the remains of small wooden brackets - possibly these held shelves or something similar connected with mending operations. There are no indications that machinery of any sort was ever operated in the building, nor any external signs of a source of mechanical power.

Overall, considering how long it has stood virtually unused, the building is in reasonable condition, the external stonework being fairly good. Internally, some of the plaster facing has fallen away, exposing a jumble of rough hewn stone, bricks and mortar in some areas. Clearly the outside had to look impressive, although this was not uncommon during the mill building boom during the first quarter of the 19th century. The roof of Welsh slate appears to be in sound condition, although doubtless some of the roof timbers and much of the internal woodwork will need to be replaced during its conversion.
