# **Cotswold Canals Restoration**

**Phase 1b. Saul Junction to The Ocean, Stonehouse**

## **Stroudwater Canal Features Influenced by the Ship Canal to Gloucester**

by Hugh Conway-Jones April 2007 Issue 1

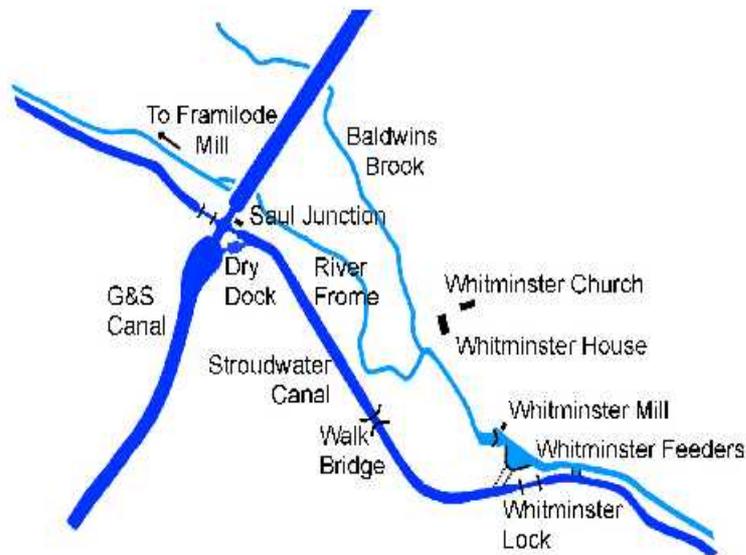
## Saul Junction (*Junction with Boat*)

Saul Junction is the only place in the country where there is an intersection of two independent canals. The Stroudwater Canal, built along the valley of the River Frome, was opened in 1779 to allow barges to carry coal up to the woollen cloth mills in the Stroud valleys, and this part of the Gloucester & Sharpness ship canal was constructed between 1818 and 1827. The initial Junction was about 40 yards north-east of the present position, the water then being at the existing level of the Stroudwater, and the first barges were able to pass between the two canals in February 1820. To allow the water level to be raised about four feet to provide the necessary depth for ships, the present junction and lock were built on a new alignment, and this was commissioned and the old line closed off in two months of intense activity during the summer of 1826 (1).

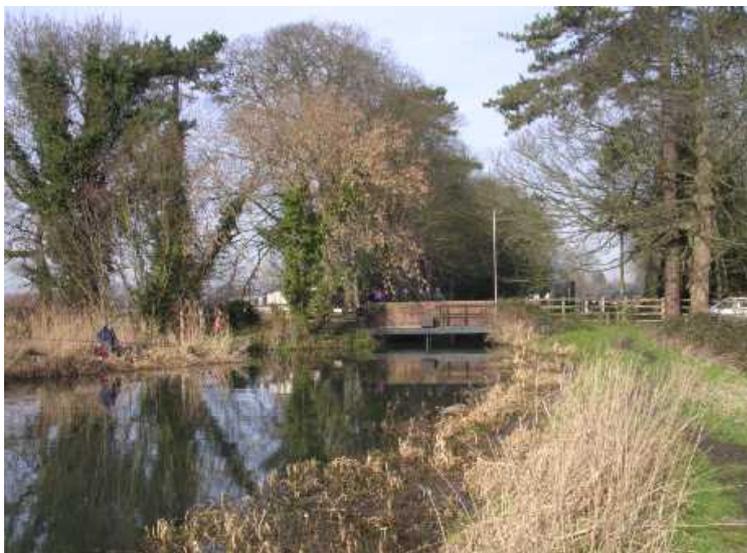
*Walk Bridge*

Walk Bridge, one third of a mile south-east of the Junction, was originally a brick-arched bridge with awkward approach gradients for those crossing. For many years, it only carried a private road that belonged to the Whitminster estate, but as time passed it was increasingly being used by the residents of Saul to pass to and from the Bristol road, in preference to going via the turnpike road through Frampton. In 1855, therefore, Mr H H Wilton of Whitminster House paid for it to be replaced by a swing bridge, pivoting on the off-side, which had much more convenient approach gradients. This new bridge was modified in 1869 when, to allow the ship canal company's steam dredger to pass along the pound, the bridge-hole was widened by two feet and the swing section was extended to suit (13).

British Waterways, who continue to maintain it. Under the bridge is a probe that monitors the flow of water that is feeding the ship canal.

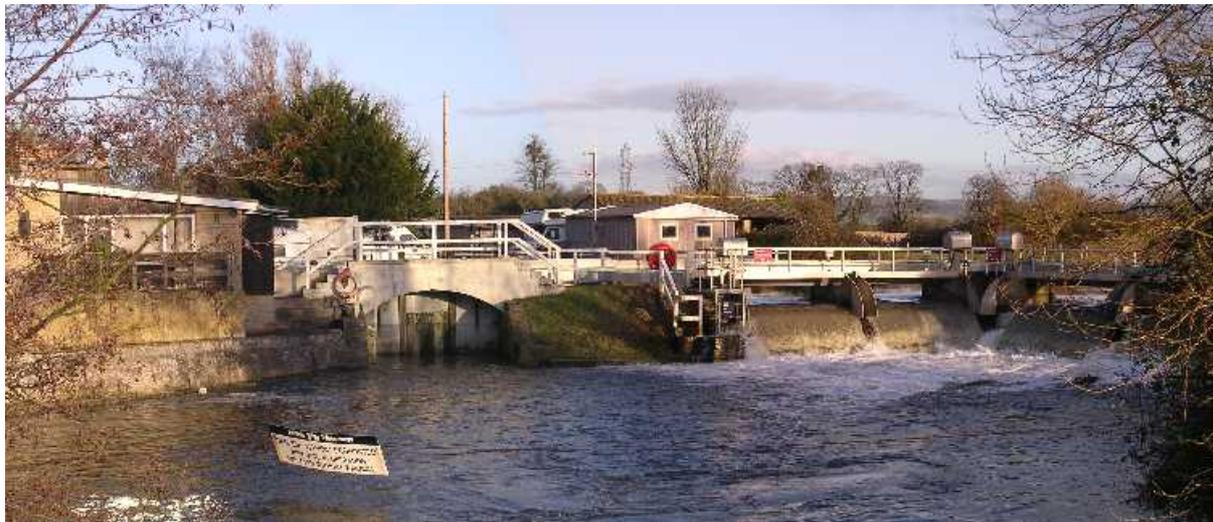
*Whitminster Weir*

The original waste weir was 23ft long along one side of the channel approaching the mill, and there were flood-gates in the wall between the weir and the mill. The original flood-gates

were replaced in 1863 by three guillotine gates with vertical rods, each operated manually via a simple gear-box mounted on a beam forming the top of the surrounding frame (18). When this arrangement was replaced in 1984, the beam and the three rods and gear-boxes were preserved, and they are now on display on Level 3 at the National Waterways Museum in Gloucester. Each gear-box carries the name W Harris Gloster and the date 1863. (Harris was an engineer and machinist with premises in Quay St.) The top of the weir was raised in 1876-77 when the ship canal company wanted to raise the level of their canal by six inches to allow larger ships to navigate to Gloucester. Because of concern that this would cause flooding upstream, they also built a large new section of weir at right-angles so that the increased width could pass more water without so much effect upstream (19).

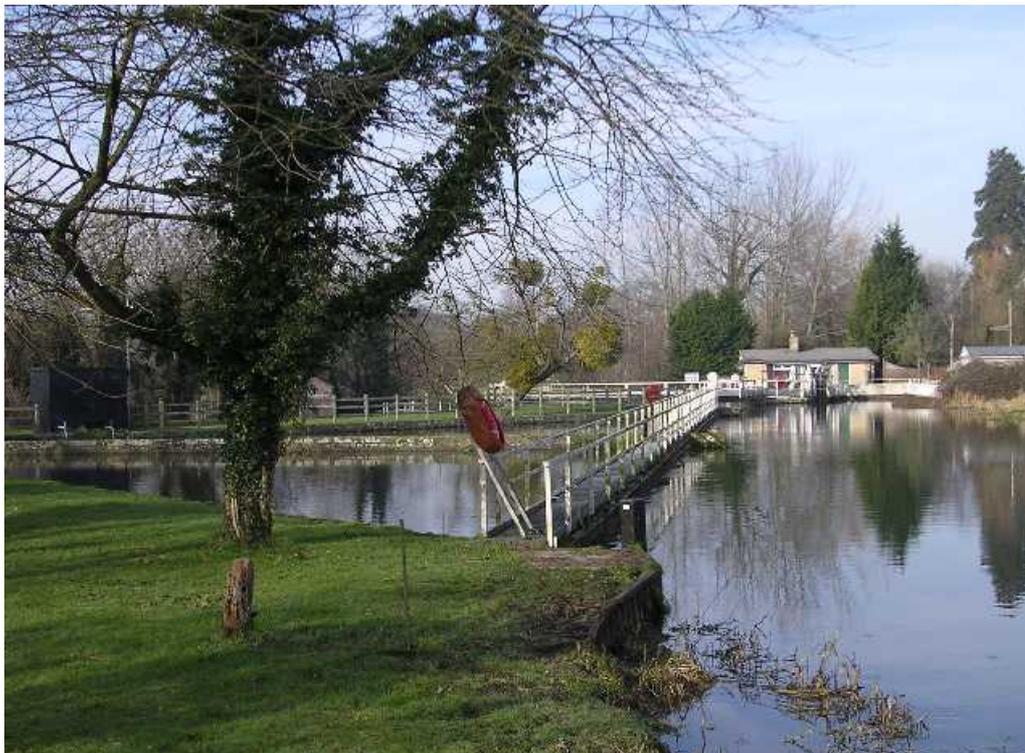
*Whitminster Feeders*

Behind a wall are the current feeders and sluices that pass water from the River Frome through culverts under the meadow and into the Stroudwater Canal below Whitminster Lock. Before the ship canal company became involved, the original water supply was via a controlled opening in the bank between the Frome and the canal above Whitminster Lock to help maintain that pound at its proper level. After the ship canal company had raised the pound below the lock by four feet, it was only a few inches below the upper pound, and when the ship canal company wanted to draw water from the Frome, the levels were equalised and the lock gates were left open to let the water flow easily. The drawback, however, was that the upper pound could not then be maintained at its proper level. The solution, authorised by the Act of 1834, was for the ship canal company to build a new supply weir, with feeders, sluices and a culvert to pass Frome water into the pound below the lock (20).

This arrangement worked well for many years until the ship canal company wanted to take more water from the Frome to make up for the extra lost through use of the new large lock at Sharpness opened in 1874. To achieve this, they rebuilt the feeders, sluices and culvert on a larger scale in 1876-77 (21), and these basic structures are still in use today, providing the main source of water for the ship canal.
