A VENTILATION FURNACE ON THE FINDALL IRON MINE, SOUDLEY, FOREST OF DEAN

**DIANA COURT
IAN STANDING**

This paper describes a primitive ventilation furnace, gives some details of early hot air ventilation practice in mines and suggests a date around 1800. Repair work was carried out over 1976/77 in the interests of preservation.

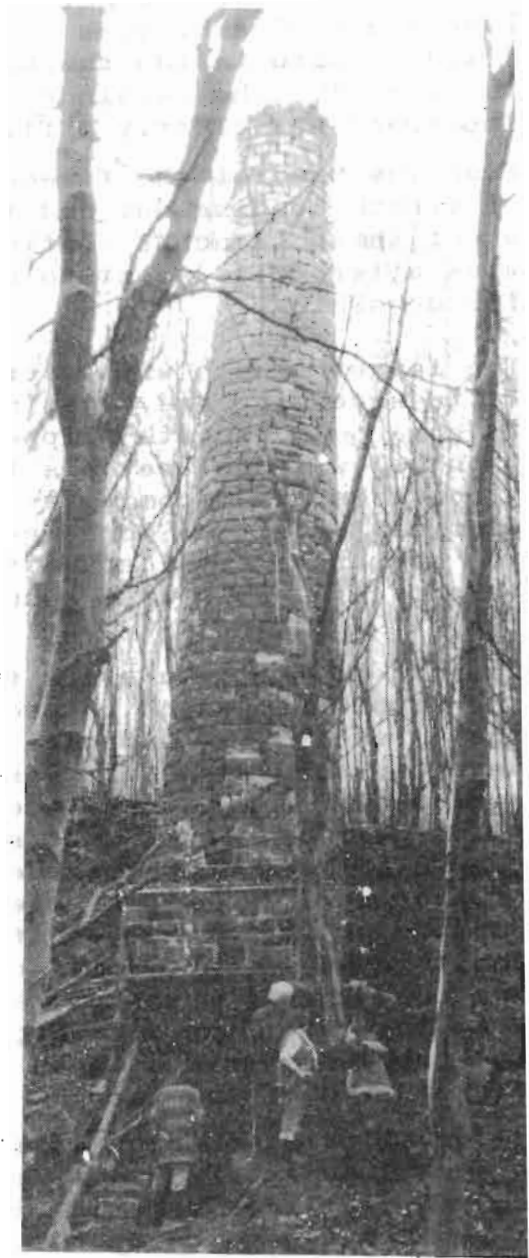
Plate 1

0.75M wide by 2.5M high. Excavation in this area, prior to repairs, revealed coal ash, some coal and some iron firebars out of situ. Fixed in situ inside the base of the stack is an iron plate visible in Plate 1. The remainder of the fill comprised fallen masonry. The space was clearly a firebox.

Prior to our work the bank sloped past the stack at around head height of the figure in Plate 1. Fallen masonry further reduced the apparent size of the aperture seen above the newly inserted lintel and we were naively convinced that a small masonry arch was all that needed replacing. We accordingly approached the Forestry Commission who owned it, for their permission and support for repair work.
