A WALK UP THE WASHBROOK

by CHRISTOPHER COX

WASHBROOK MILLS in 1961

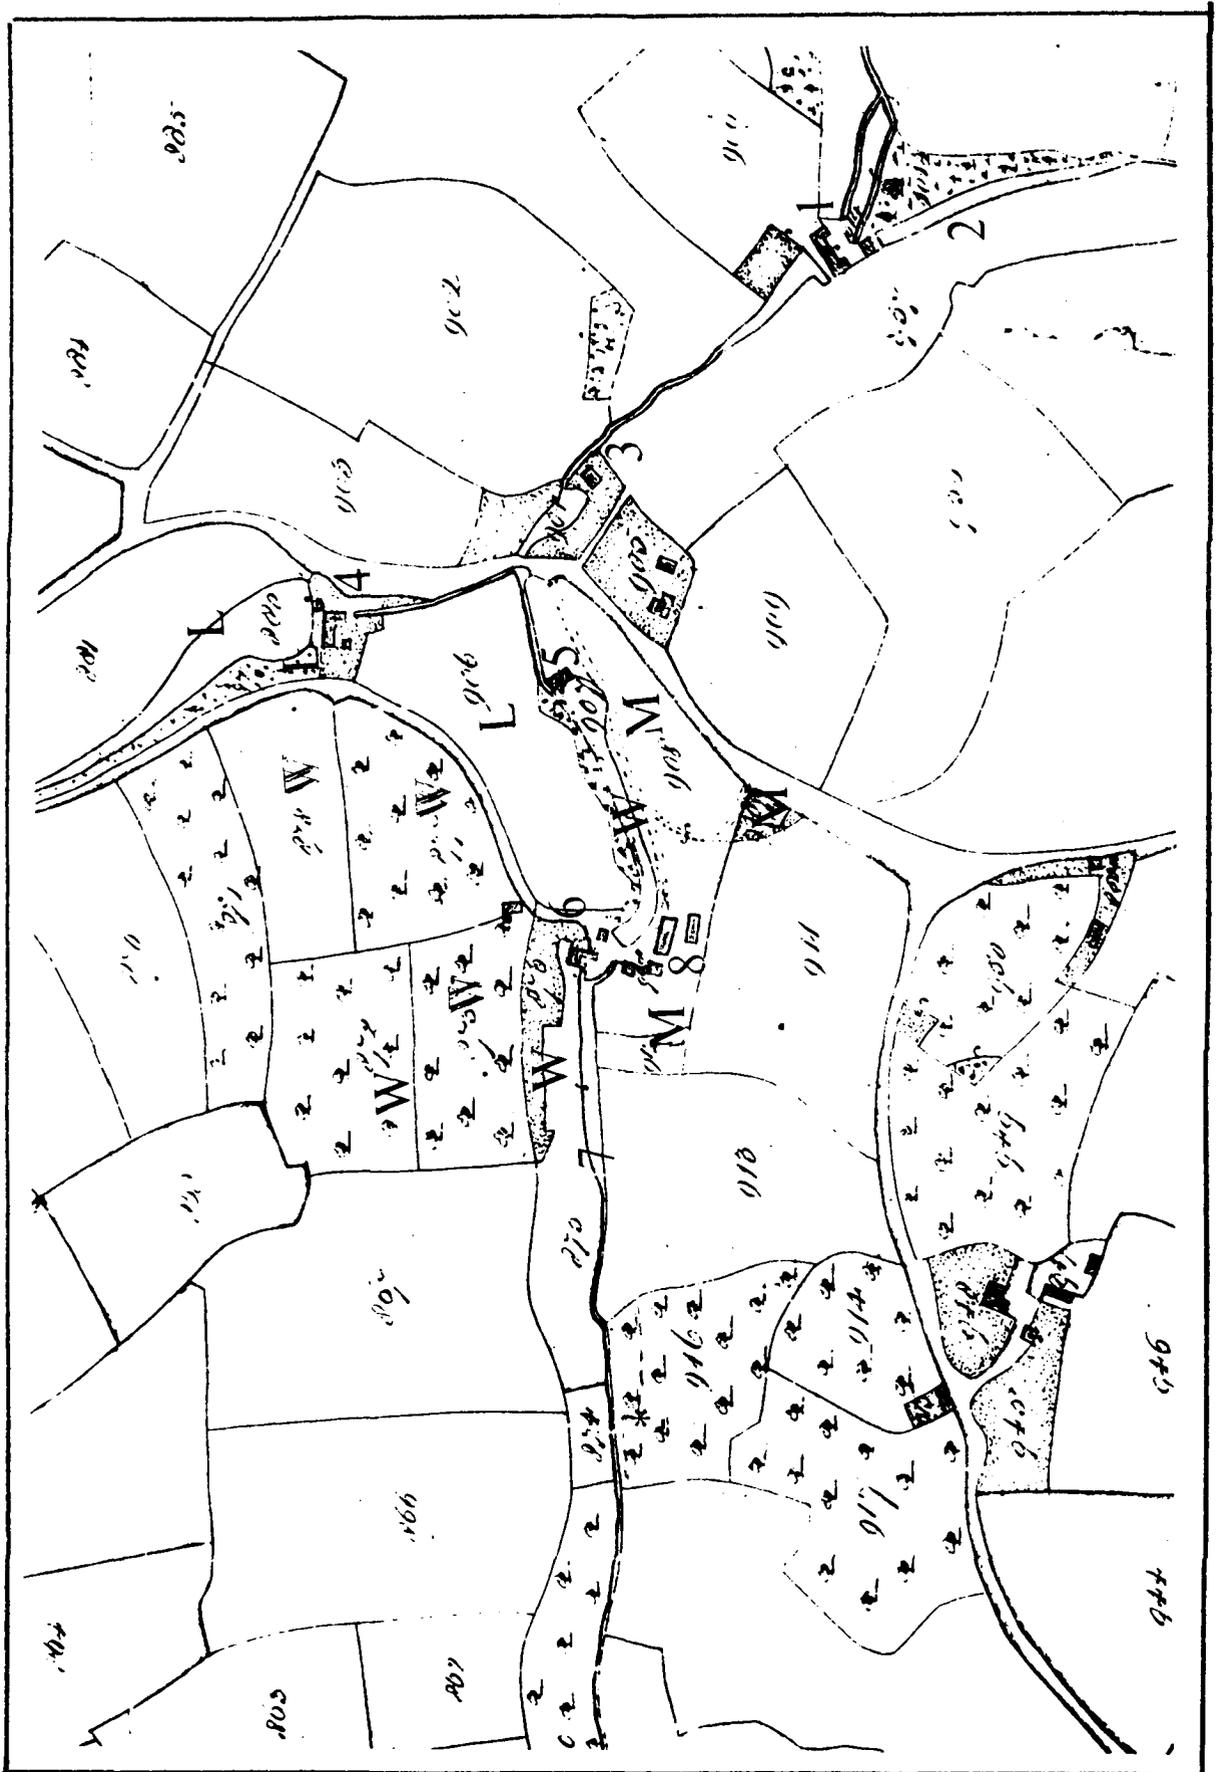
Within a short stretch of this valley, as the extract from the Painswick Tithe (Edge Tithing) map shows, the aspiring archaeologist will find an excellent introduction to an investigation into the remains of an industry based on water power - all at one time in the cloth trade. So with Mrs Haine's account to hand, and using the footpaths (!) it is possible to observe the sites, and scanty remains, of a one-time rural industry. And all too clearly it can be seen how quickly buildings, mill-ponds and dams can disappear: and how too manufactories which have lost their function can either vanish - or be changed to alternative use. What happened so recently to industrial sites is now, of course, also happening to farms, and this area can provide many examples of that change of function too.

The numbers on the Tithe map extract refer of course to the Award Book - owner, occupier, area, use etc. This, and the map itself, can be seen in the Gloucestershire Records Office.

- 1 The Washbrook mill. The siting of the mill, and the outline of the mill pond. Note the carving over the doorway, for which see Mrs Haine's article on this mill.
- 2 The "reserve" pond. This is hardly shown on the 6 in. Ordnance map of the 1950s, but appears both on the Tithe map and on Bryant's map. First seen by the writer in company with Lionel Walrond of the Stroud Museum, it still retained water. As it had been fed by the rill below the Edgemoor Inn (formerly the Gloucester House) on the Stroud-Gloucester road, which had been diverted towards the mill, the resumption of that rill's natural course prevented the pond from silting up like the other mill ponds in this valley.

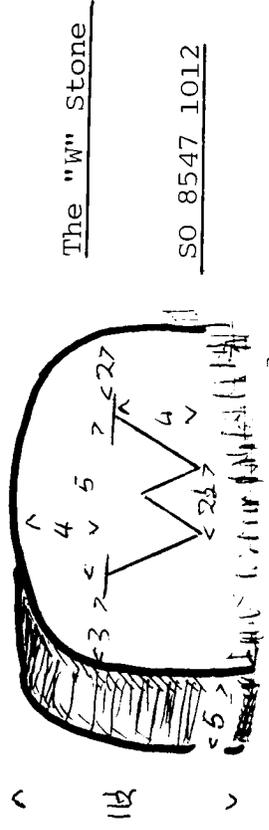
The "W" Stone

This leads us to a small puzzle. Miss Faith Gray (now Mrs Hale of Brookthorpe) pointed out to the writer a round-headed stone at the corner of a narrow enclosure by the stream at the head of the pond, which bore the letter W. 19th century maps show that a good deal of field rearrangement took place, and this particular field & hedge does not appear on the Tithe map. A reasonable conjecture is that it marked a water right of Sam Wood, perhaps against possible infringement by the Marling firm (see J Tann's book on Gloucestershire Woollen Mills). Two similar stones were seen 20 years ago on the leat and stream above Upton mill - but a recent visit showed that the leat there, and one stone had gone (the other was not visited).

SO 8547 1012

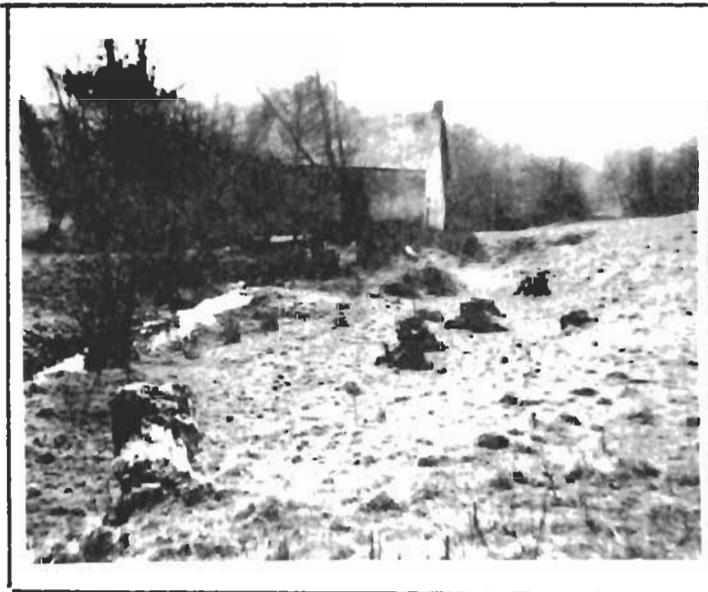
The Little/Upper mill from road bridge: willow stumps show edge of former pond.

3 The Little or Upper mill. In the 1960s it was still in use as a cowshed. Inside one could make out the water entry, the wheel marks on the wall, and various bits of machinery. Of three floors, the 1st floor bore a good stone fireplace: the floors themselves had disappeared. Outside, hillside soil-creep had all but covered the hillside window. The mill-pond was outlined by a few willows; part of the stone sluice gate was still there. (See photo). The building has now been enlarged/rebuilt, and is a dwelling house.

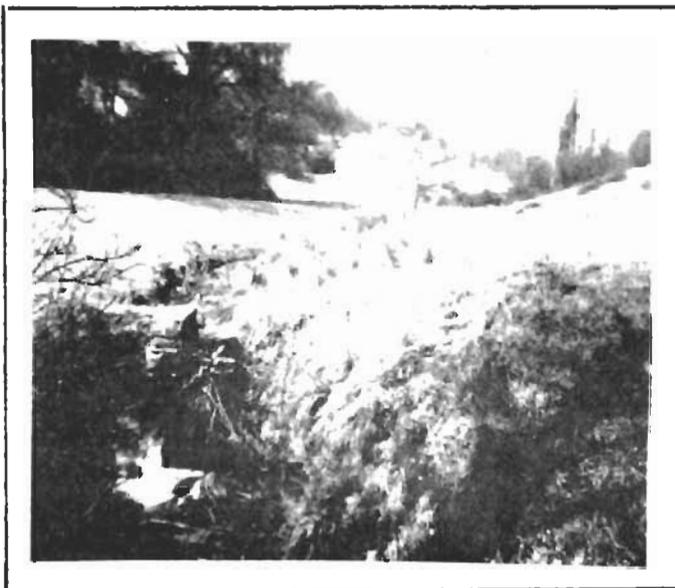
Lower Doreys site looking upstream. Dam and stonework shown. In background, workshops of Upper Doreys.

5 Lower Doreys mill. Just above the road bridge, the low mound of the dam can still be seen together with some stonework (see photo). No trace of the buildings can be seen, and the pond too is almost undetectable. But on one occasion, a small fish was seen lurking in the brook, outlasting the works of man.

(see Mrs Haine's account), but the buildings on the other side of the brook are still there, now dwellings. These appear in the background of the photo of Lower Doreys.

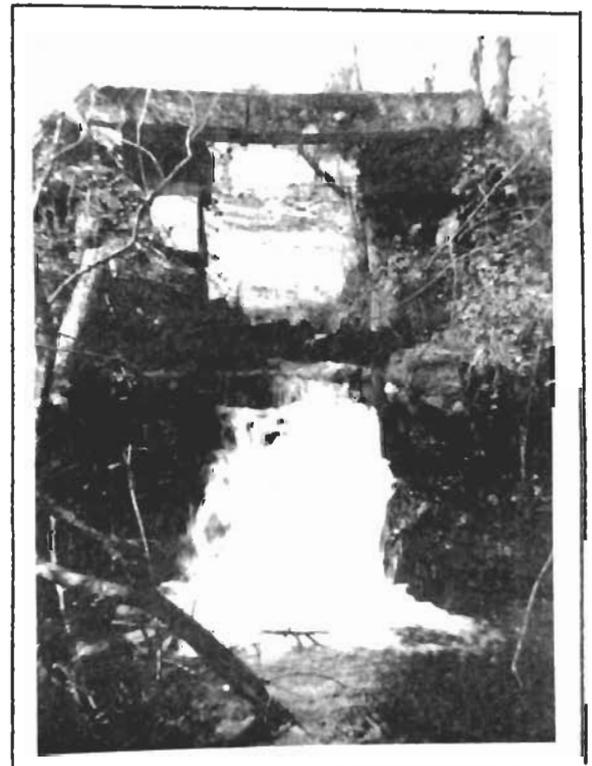
Sluice of the Little/Upper mill.
