THE MALTHOUSE AND THE BREWHOUSE, THE OLD BREWERY, BROCKHAMPTON, GLOUCESTERSHIRE

Amber Patrick

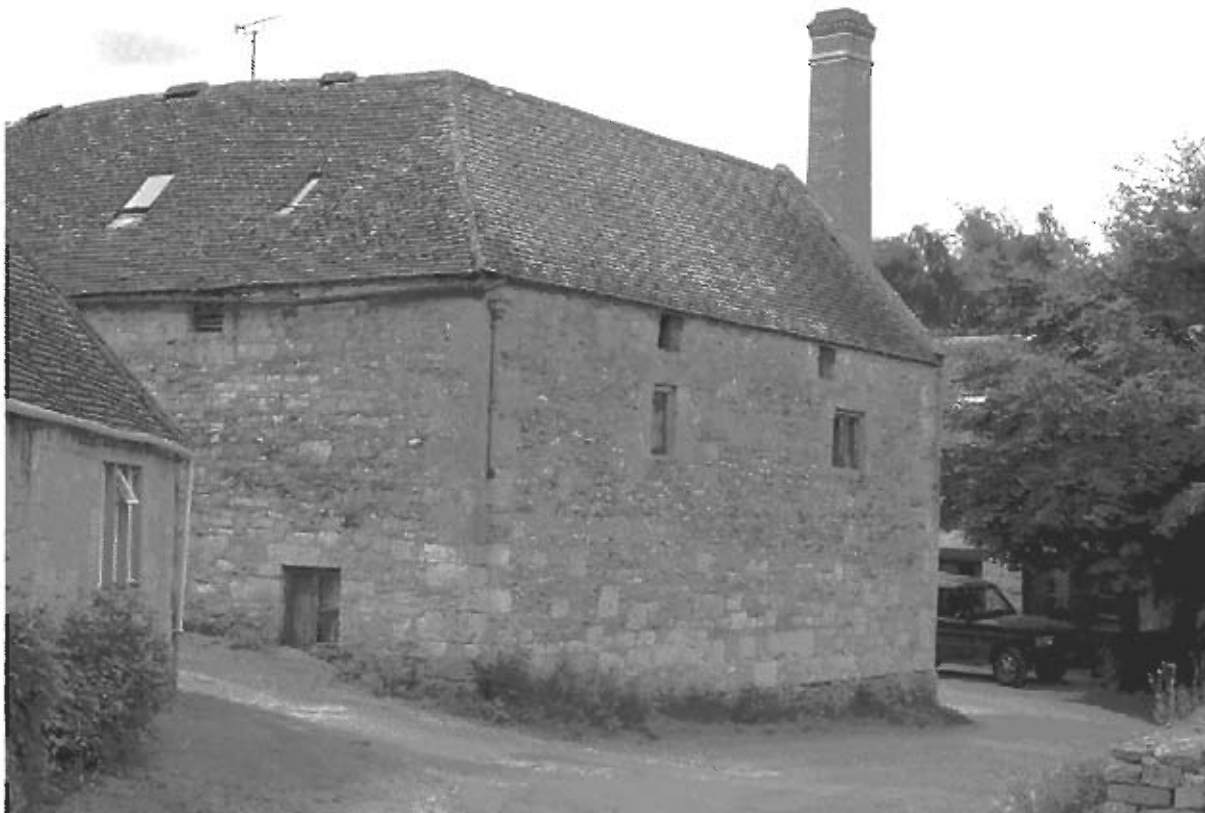
As one approaches the site, from the village and therefore from the east, the first building one sees is the malthouse and the bulk of its north wall (Figure 2). Round the corner is the west elevation which forms a double gable. (The south elevation is attached to the brewery residence.) The east elevation is partly hidden by neighbouring buildings.

The bottom part of the walls and the corners of the building are of coursed and dressed stone blocks. The upper parts of the walls are constructed of coursed rubble. The east elevation has windows on all three floors, but they are irregularly spaced. The north elevation which fronts on to the road has small windows to the middle and top floors only. As already indicated, the bottom floor presents a blank mass. The west elevation has a door at ground floor level in each gable wall. The north gable has a window to the top floor but the south gable has doors at both the middle and top floor levels. The date stone (1769) is above the door of the north gable. It would appear that the southern gable was a later in-fill.

Figure 3. North Elevation of the Malthouse
