STROUDWATER CANAL FEATURES INFLUENCED BY THE SHIP CANAL TO GLOUCESTER

Hugh Conway-Jones

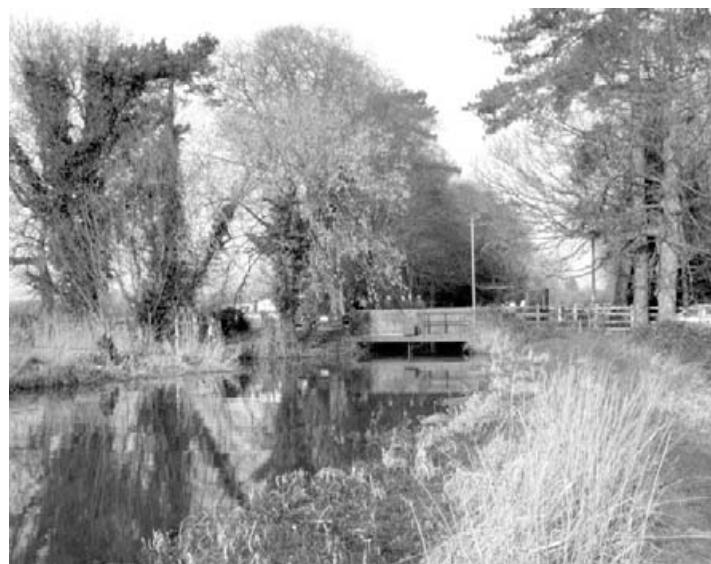
Walk Bridge

Walk Bridge, one third of a mile south-east of the Junction, was originally a brick-arched bridge with awkward approach gradients for those crossing. For many years, it only carried a private road that belonged to the Whitminster estate, but as time passed it was increasingly being used by the residents of Saul to pass to and from the Bristol road, in preference to going via the turnpike road through Frampton. In 1855, therefore, Mr H H Wilton of Whitminster House paid for it to be replaced by a swing bridge, pivoting on the off-side, which had much more convenient approach gradients. This new bridge was modified in 1869 when, to allow the ship canal company's steam dredger to pass along the pound, the bridge-hole was widened by two feet and the swing section was extended to suit (13).

By the 1950s, the condition of this bridge and of another were causing concern to Gloucestershire County Council, the highways authority. As commercial use of the canal had died out, the Stroudwater company had no money for bridge replacement, and so in 1954 they agreed to an Act to abandon the canal for navigation and to transfer the responsibility for the bridges to the County Council. The swing bridge was replaced by fixed concrete decking, and this became the limit of navigation along the arm. As there was still a need for water to be taken from the Frome to feed the ship canal, ownership of the arm passed to what became British Waterways, who continue to maintain it. Under the bridge is a probe that monitors the

flow of water that is feeding the ship canal.

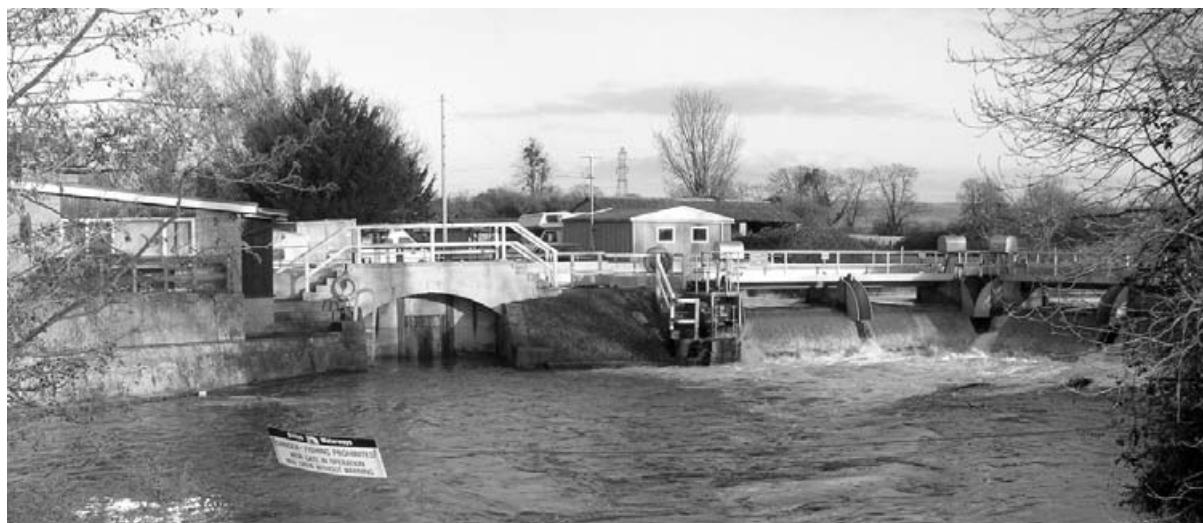
Whitminster Weir

The agreement to purchase Whitminster Mill required the ship canal company to demolish the buildings and not rebuild anything except a house for the man to take care of the flood gates and sluices that controlled how much water was taken from the river (17). The resulting house was a single storey structure in the classical style with a pediment at the front supported by two Doric columns. This design was probably chosen to please Mr C O Cambridge of nearby Whitminster House who had been very helpful during the earlier dispute. This interesting building was replaced by the present bungalow in the 1960s, but the design can still be seen as it was used again for the early bridge houses along the ship canal.

The original waste weir was 23ft long along one side of the channel approaching the mill, and there were flood-gates in the wall between the weir and the mill. The original flood-gates were replaced in 1863 by three guillotine gates with vertical rods, each operated manually via a simple gear-box mounted on a beam forming the top of the surrounding frame (18). When

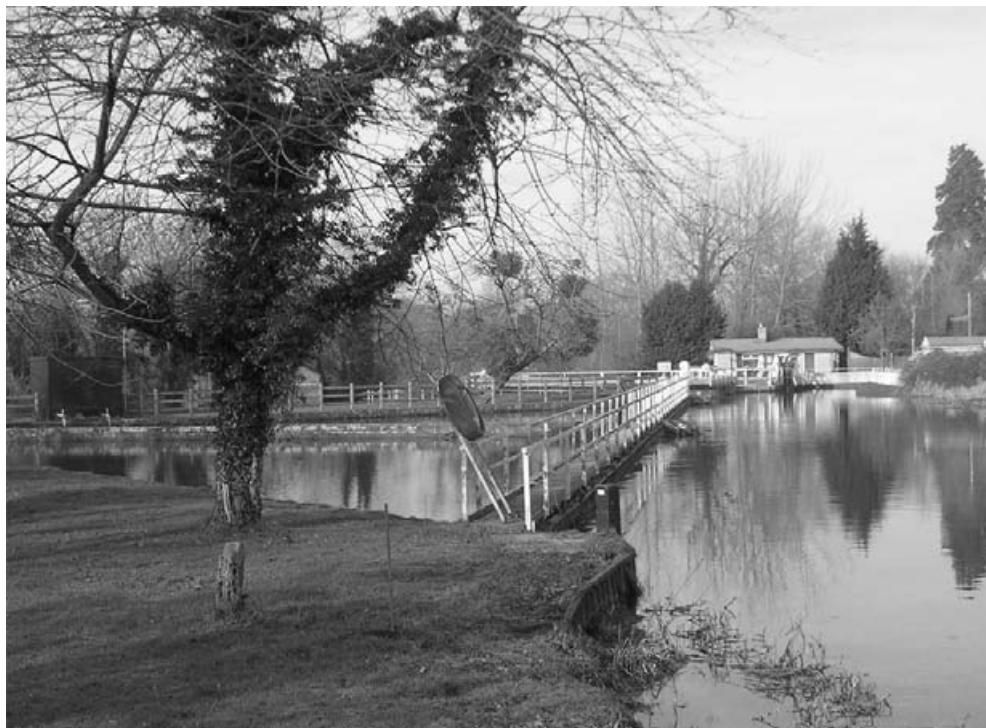
Whitminster Feeders

Behind a wall are the current feeders and sluices that pass water from the River Frome through culverts under the meadow and into the Stroudwater Canal below Whitminster Lock. Before the ship canal company became involved, the original water supply was via a controlled opening in the bank between the Frome and the canal above Whitminster Lock to help maintain that pound at its proper level. After the ship canal company had raised the pound below the lock by four feet, it was only a few inches below the upper pound, and when the ship canal company wanted to draw water from the Frome, the levels were equalised and the lock gates were left open to let the water flow easily. The drawback, however, was that the upper pound could not then be maintained at its proper level. The solution, authorised by the Act of 1834, was for the ship canal company to build a new supply weir, with feeders, sluices and a culvert to pass Frome water into the pound below the lock (20).
