THE MALTHOUSE, TANHOUSE FARM, CHURCH END, FRAMPTON ON SEVERN, GLOUCESTERSHIRE

Amber Patrick

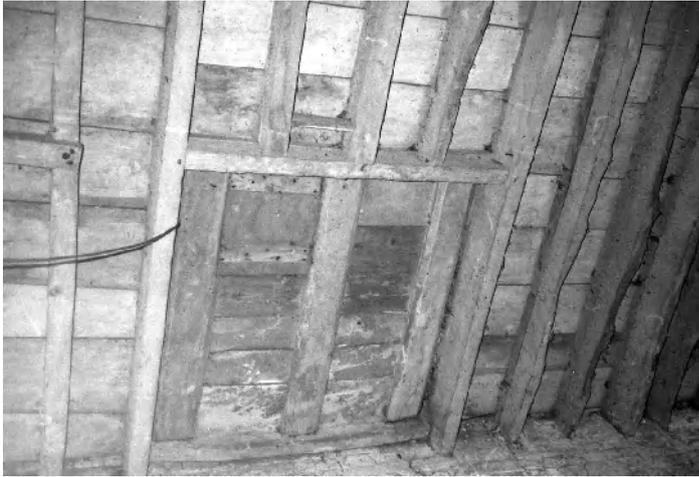
Fig. 3 Hatch at south eastern end of top germination floor

A sort of screed surface survives on the top floor, but it is much worn and has become friable. The screed is laid on broad wooden boards on joists in turn support by substantial main beams running northeast to southwest. There is a hatch surviving in this floor at its south eastern end (Figure 3). Through this hatch baskets of part germinated barley would have been hoisted so that growing could be completed on the floor adjacent to the kiln drying floor. There were the remains of the baskets on this top germination floor.

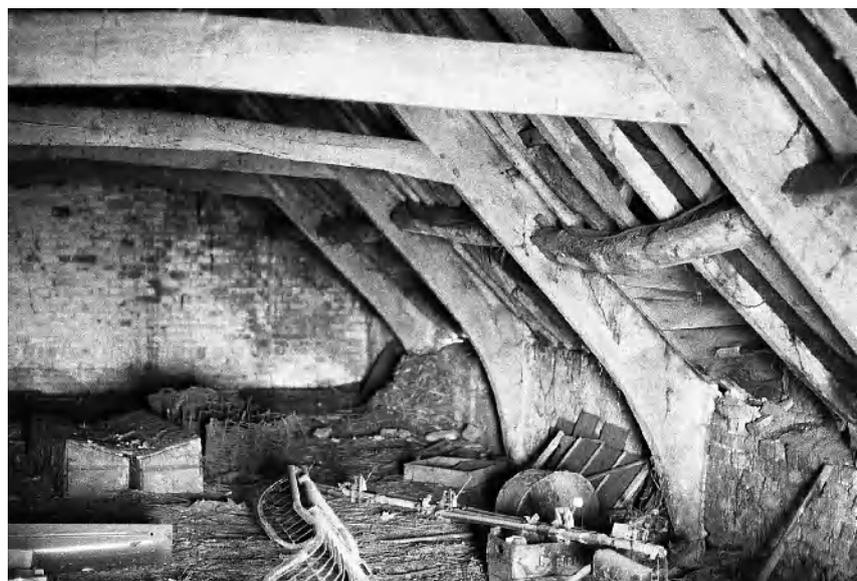
Figure 4 Interior - top floor showing roof structure

The top floor has a fine roof structure surviving (Figure 4). The upper cruck roof trusses rise up through the top part of the brick wall to the ridge which is pegged. There are two sets of purlins with a collar located between them. The dormers which cut through it have sloping cills to prevent any grain from becoming

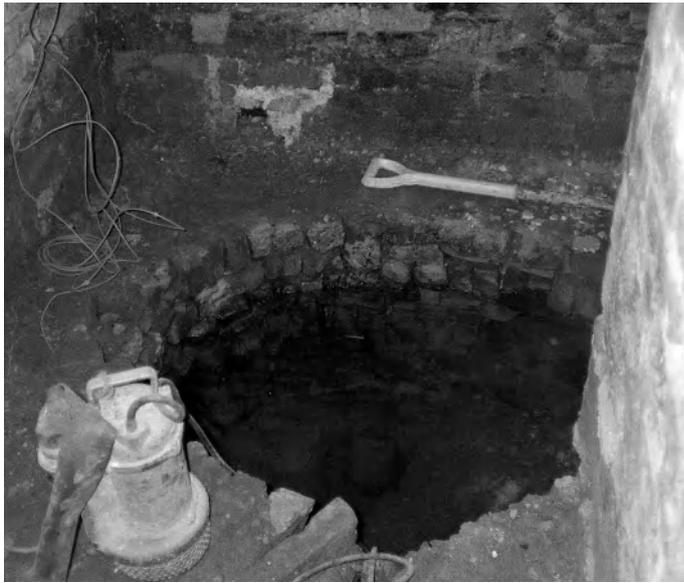
Figure 5 Well in kiln furnace room (steep on the other side of the wall on the left hand side of picture

The kiln furnace room is reached via a broad door from the bottom floor of the malthouse and adjacent to the steep. There is a large well more or less in the northeast corner of the kiln room, adjacent to the wall separating the kiln from the steep (Figures 5).

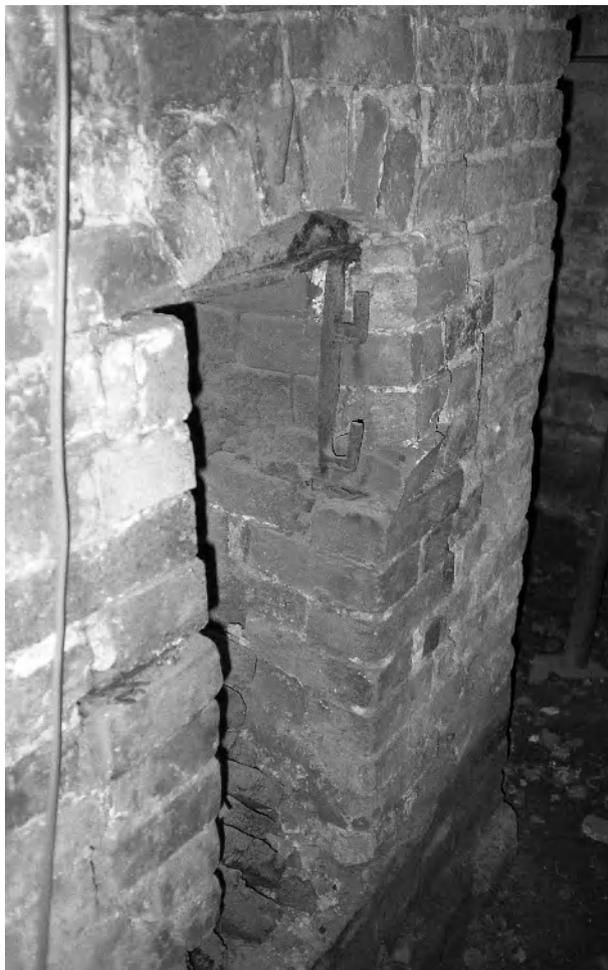
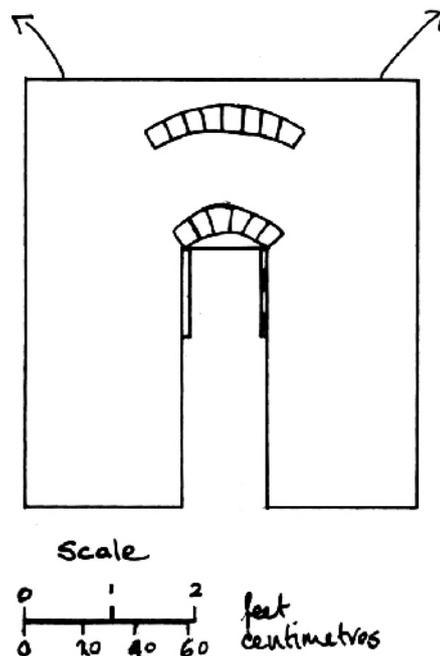
Figures 6 and 7 Kiln furnace mouth

The furnace shaft rises to barrel vaults to the exterior walls. The furnace is built of brick and is centrally located. The furnace mouth faces north west and consists of a small mouth with a segmental head of six header bricks (Figures 6-7). Originally there would have been fire bars for the fuel but these had gone by the time of 2000, although the iron surround of the furnace did survive. No doors are extant but the hinges remain. There is a

blocked ventilation hatch above the kiln furnace mouth and it has a segmental head of six header bricks. There are also two ventilation hatches at floor level in the south east elevation.
