MILLEND MILL – PART 2 THE BOULTON & WATT ENGINE HOUSE

Stephen Mills

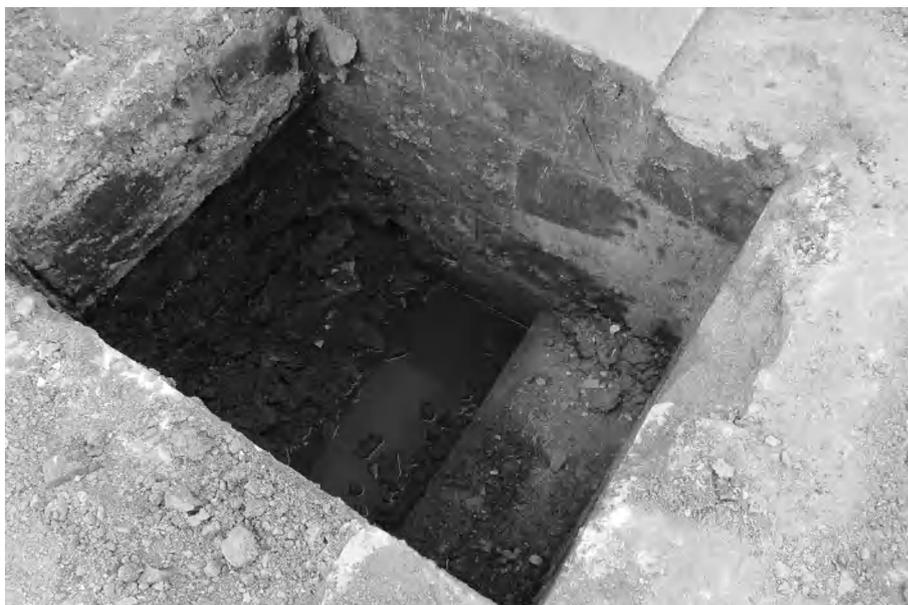
Figure 5. Excavation between two of the engine platforms showing the depth of the stone foundations and the small access tunnel (filled with mud) running beneath them.

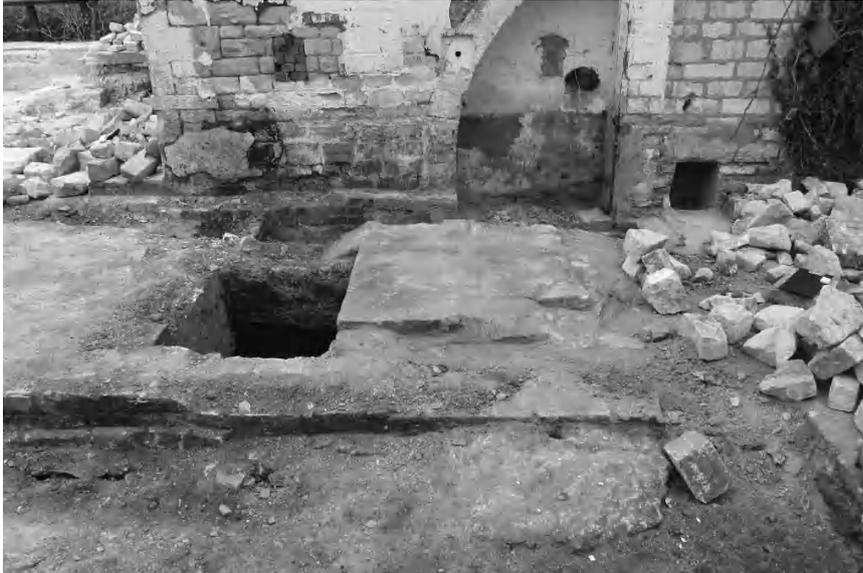
Figure 6.
The surviving large stone platforms that carried the engine's main components.

The blocked opening in the main mill wall behind probably formed part of the power transmission arrangements.

carried the engine's main components. These comprise three substantial stone plinths that supported the engine's main axle, central supporting columns for the beam, and the cylinder. Beneath these, excavations carried out also uncovered the access 'tunnel' running beneath almost the full length of the engine house (Figure 5). Remarkably, although no iron components remained in situ, much of the arrangements to accommodate the engine remain largely intact below ground level. These are composed mainly of blocks of stone of such a size and weight, that they were left in place when the engine house was demolished and built over (Figure 6).

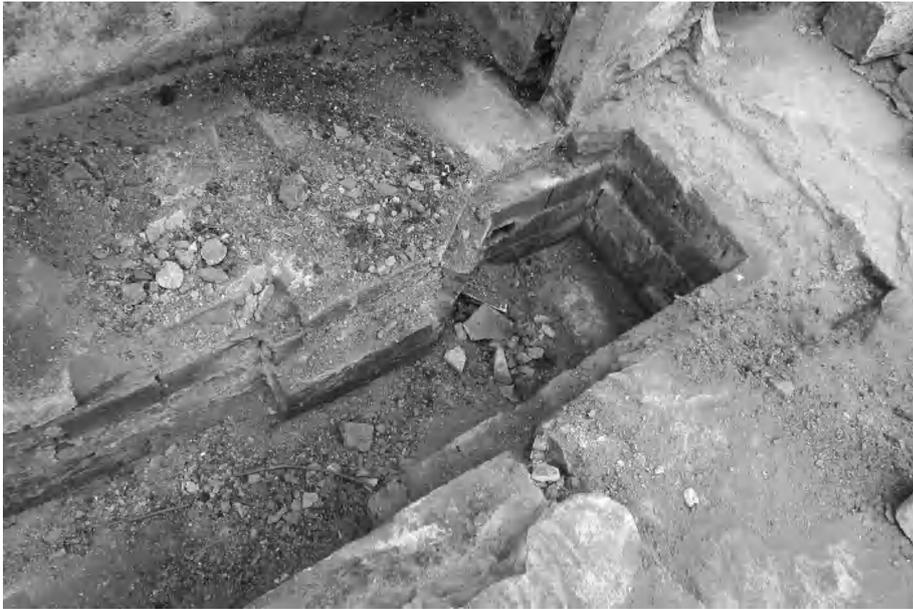
Figure 8.
Excavation of part of the slot for the Millend engine's fly-wheel. The brick additions are thought to be a later modification. The lower section appears to have been filled with concrete.

The slot for the engine's flywheel was also revealed, located immediately adjacent to the main mill's eastern wall (Figure 8). This had been partially infilled with concrete and now incorporates several later brick-built modifications (function unknown). Excavation revealed that the slot was at least 18 feet in length although the outer end had been destroyed by later works; possibly a further 4-5 feet once existed. The diameter of the engine's flywheel (assuming it was

the same as the Churchend Mill engine) would have been 18 feet. The slot's width varies between 20 and 22 inches although it may have originally been wider, as at some stage, it has been lined with bricks, effectively narrowing it. The depth of the slot down to the concrete infill is now only around 20 inches.

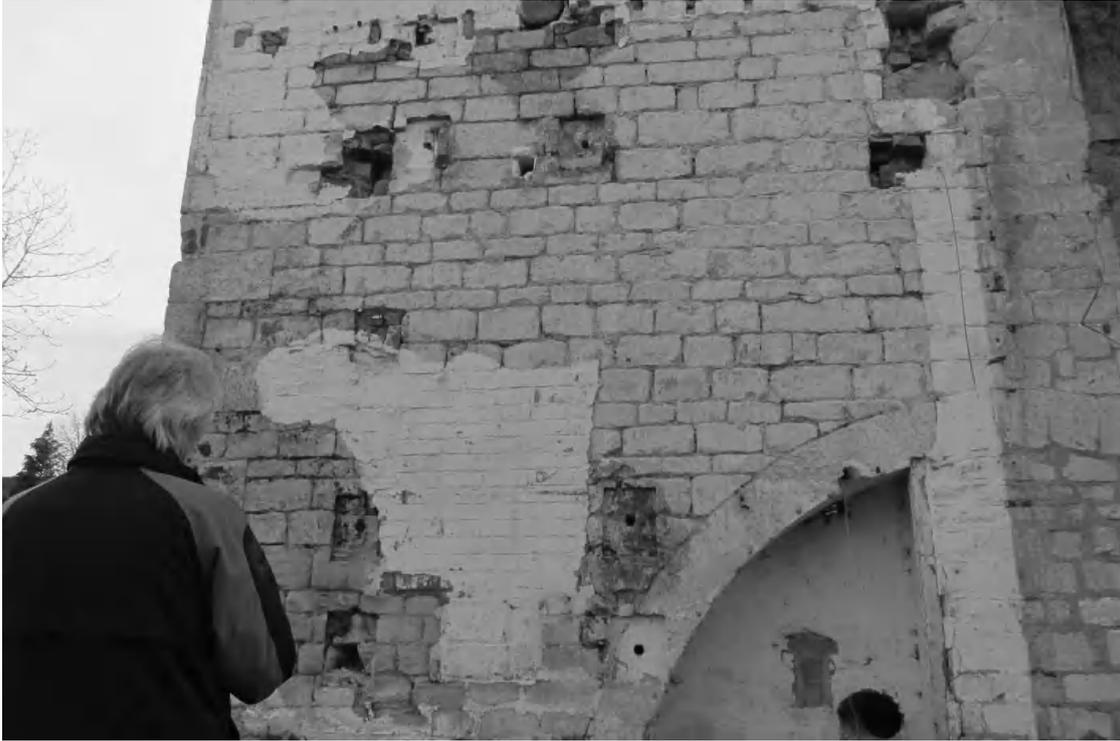
Figure 9 The main mill wall showing where the engine house once overlapped; the white line on the right indicates the one end wall. Note the earlier stone access arch, closed off when the engine house was added. Also note the openings cut high in the mill wall for the engine house roof beams and transverse engine supports, and the rectangular openings cut for reinforcement plates – these are thought to be associated with power transmission arrangements into the mill. The row of blocked upper holes carried the joists for the engine house’s upper floor.

Several blocked openings let high up into the mill's eastern wall suggest that they once carried transverse reinforcement beams for the upper part of the engine. Based on the drawings of the Churchend Mill engine house, it appears that there was an upper floor and that the roof was carried on three main beams set transversely across its width - there are two openings cut into Millend Mill's eastern wall at the appropriate height that appear to match up with two of these supports. The third one would have been in the section of the engine house that extended past the main mill. Below these openings are a line of blocked joist holes that presumably carried the upper floor above the engine (Figure 9).

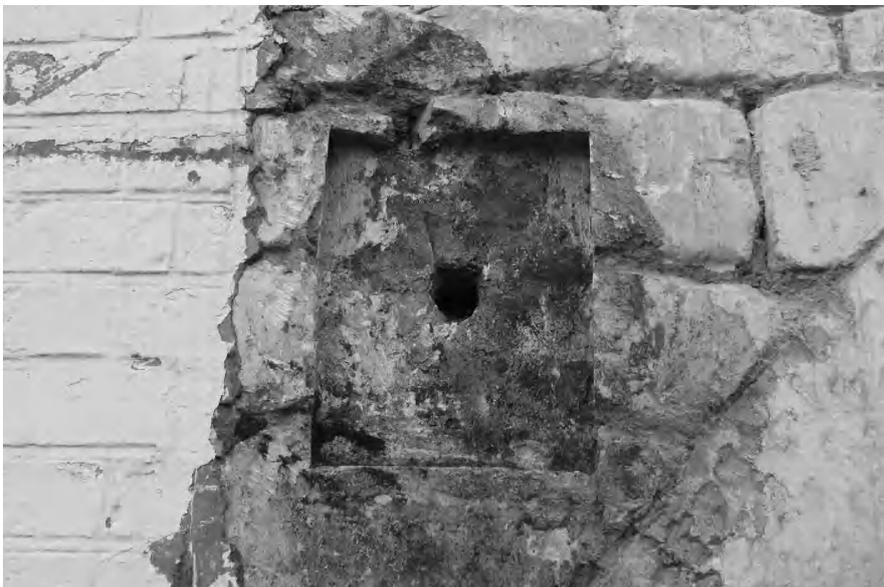
Figure 10. Close-up of one of the recesses cut for supporting plates. The bolt holes pass right through the mill’s wall. These presumably provided reinforcement for part of the power transmission arrangements.

recesses (11 inches wide, 14 inches tall, and 1.5 inches deep) have been cut into the stonework, each with a central 2 inch diameter bolt hole passing through the wall. There is also at least one more such recess set higher up in the wall. These appear to have held iron reinforcing plates that once formed part of the arrangement for transferring the engine’s drive into the mill. The vertical distance between the circular holes is 25 inches, and exactly 5 feet horizontally (Figure
