EIGHTEENTH CENTURY SLAG CONSTRUCTION BLOCKS IN GLOUCESTERSHIRE - A SURVEY

Nigel Spry

From 1996, members of the Gloucestershire Society for Industrial Archaeology, the Gloucester and District Archaeological Research Group, the Forest of Dean Local History Society and the Bristol and Gloucestershire Archaeological Society, together with other fieldworkers, have undertaken a systematic survey of the locations and use of 18th century Slag Blocks in areas of the present county of Gloucestershire where they occur. This article explains the background to the subject, outlines the methodology of the survey and provides a summary of the results.

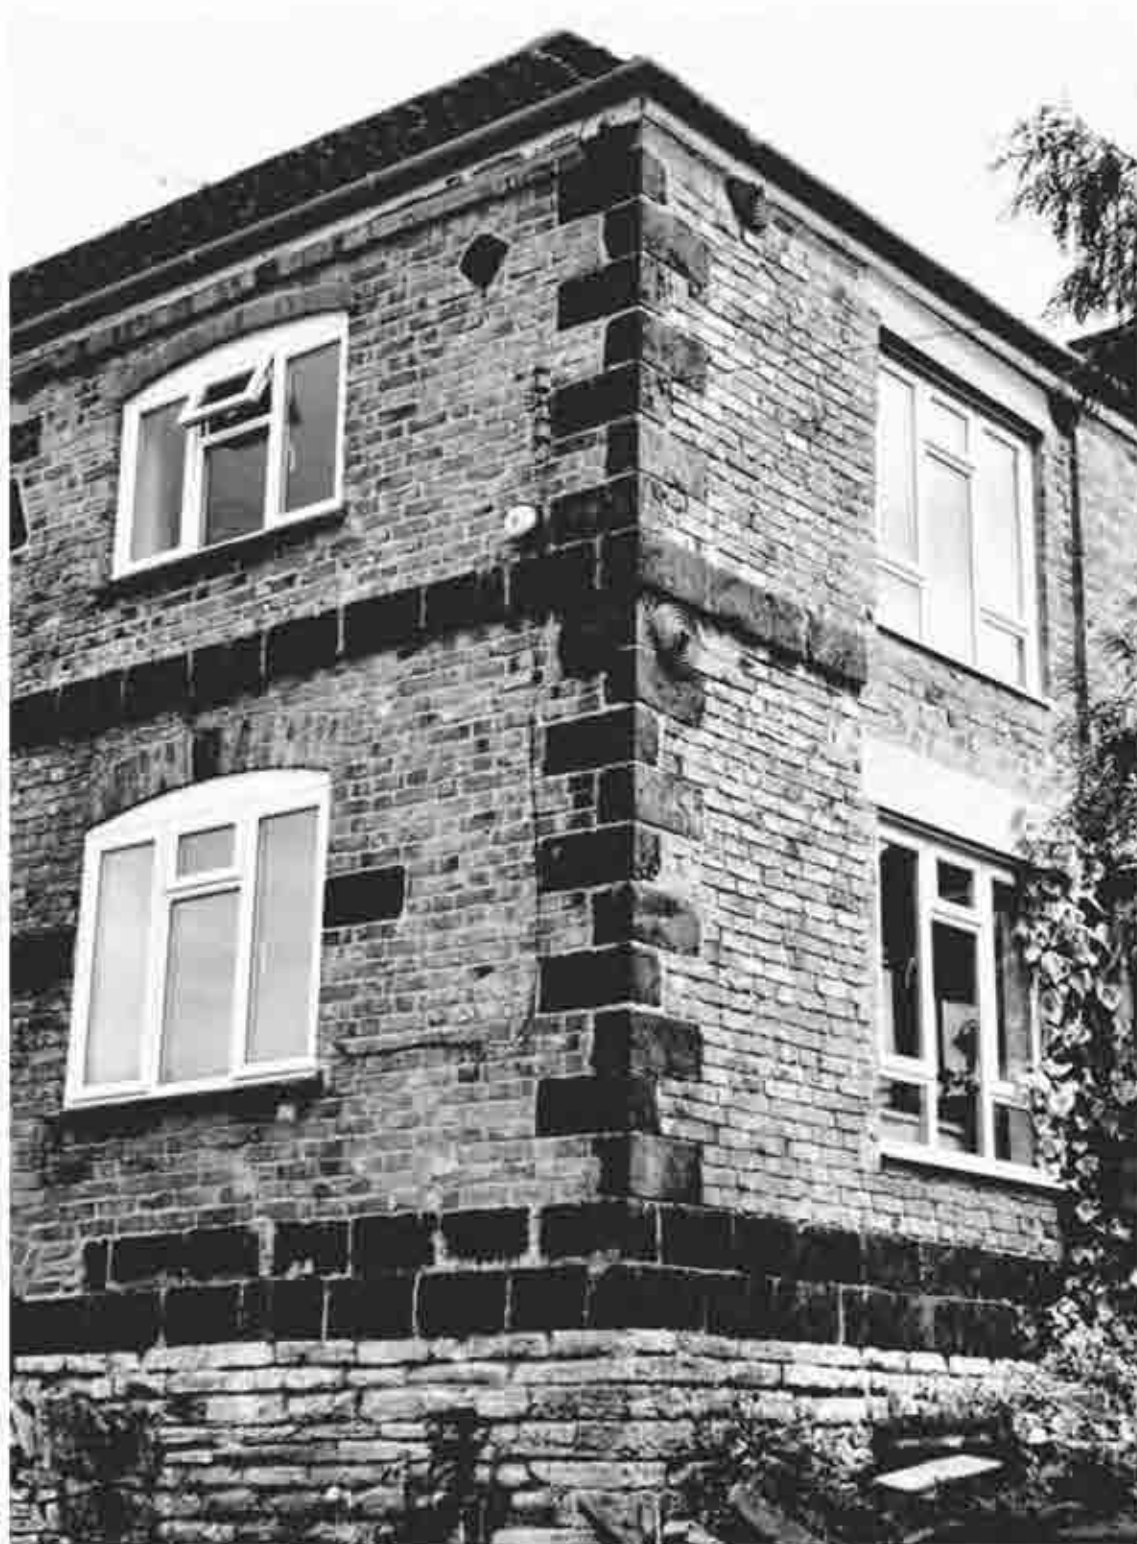
Figure 7. Use made of slag blocks at Corner House Farm, Corse

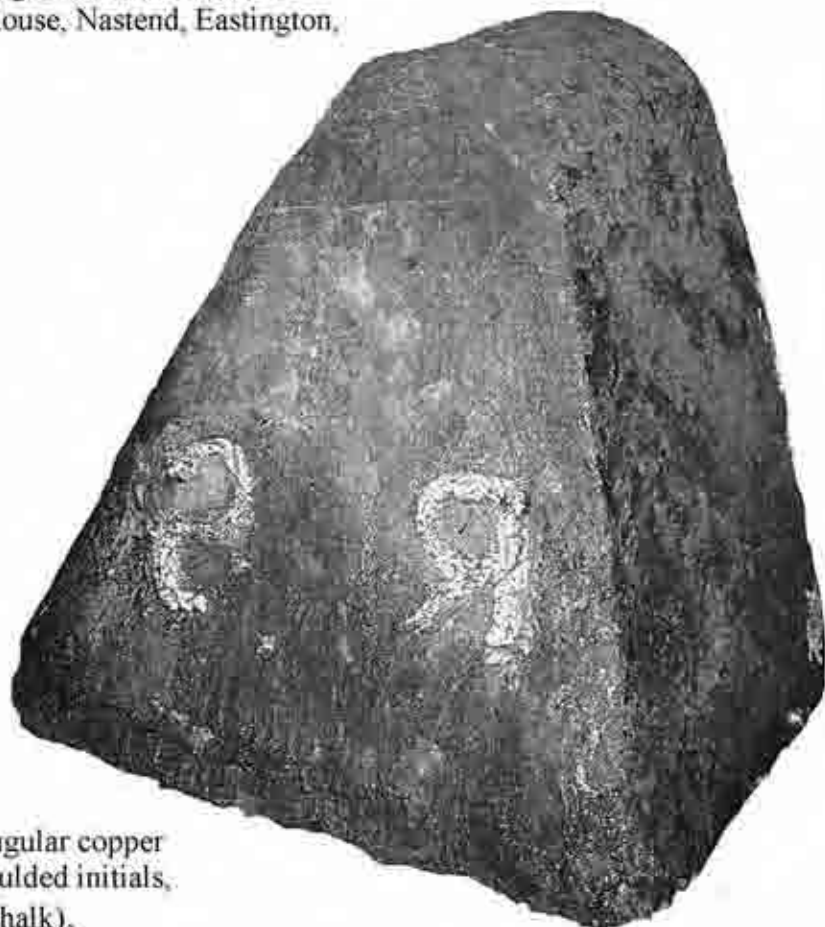
Figure 10. Non-standard triangular copper slag block with moulded initials, (highlighted with chalk), recovered from Ham and Stone.

trackway gate west of Whitecliffe Park (Figure 10). Reversed R and S are clearly shown in relief, these letters originally having been depressed in a vertically tapering mould set unspaced side-by-side (co-joined) with a standard triangular one prior to casting. It seems likely that the block was used, or intended, as a property or field boundary (mere) stone. This is the only known local example of a mould mark, but Stephen Hughes quoted Roman numerals on rectangular blocks used as wall copings at one site in South Wales.(56) Double-length triangular blocks, from co-joined regular moulds were recorded at Redbrook including on the Lower Redbrook copperworks site, but nowhere else.

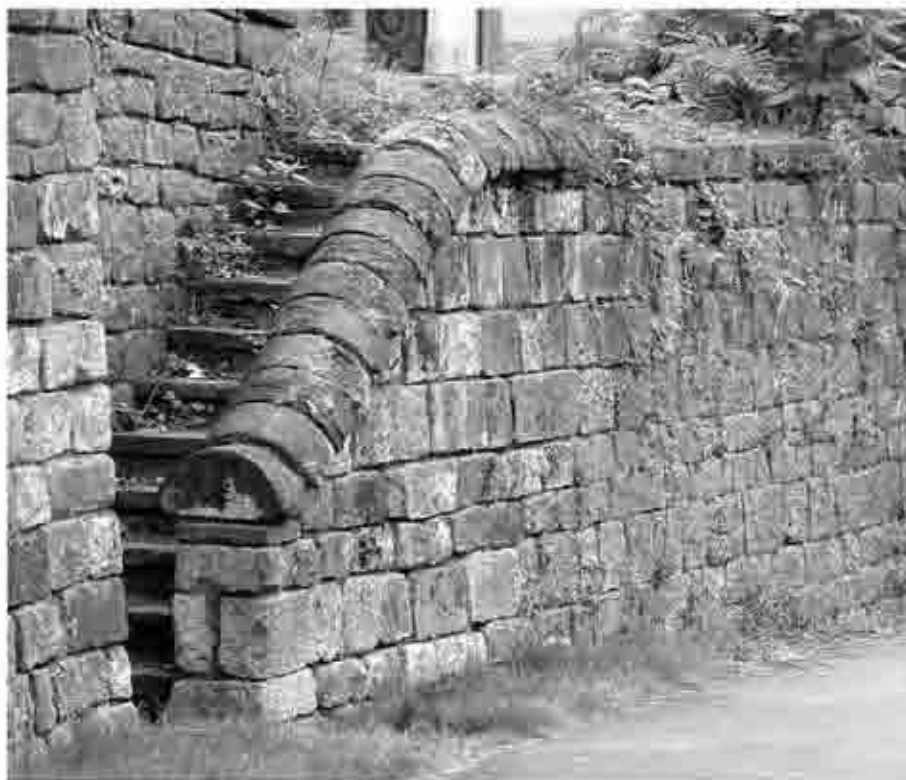
Figure 11. Half-round copper slag blocks being reused at Lower Redbrook

Half round wall coping blocks (Figure 11) are less common, being found at eleven locations, all to the west of the Severn, including at the Lower Redbrook copperworks and nearby Highbury Farm, Newland where they formed caps on a crenellated facade. Their average dimensions are 220mm high, 435mm wide and 205mm long. Such blocks were also used to make a column at Hill House, Newnham-on-Severn. Larger half round blocks were employed to construct the columns supporting the first floor of the warehouse at Newnham quay. These blocks are 305mm high (though used flat), 615mm wide and 200mm long. Large half-round blocks, though apparently shallower, also topped part of the Highbury Farm facade.

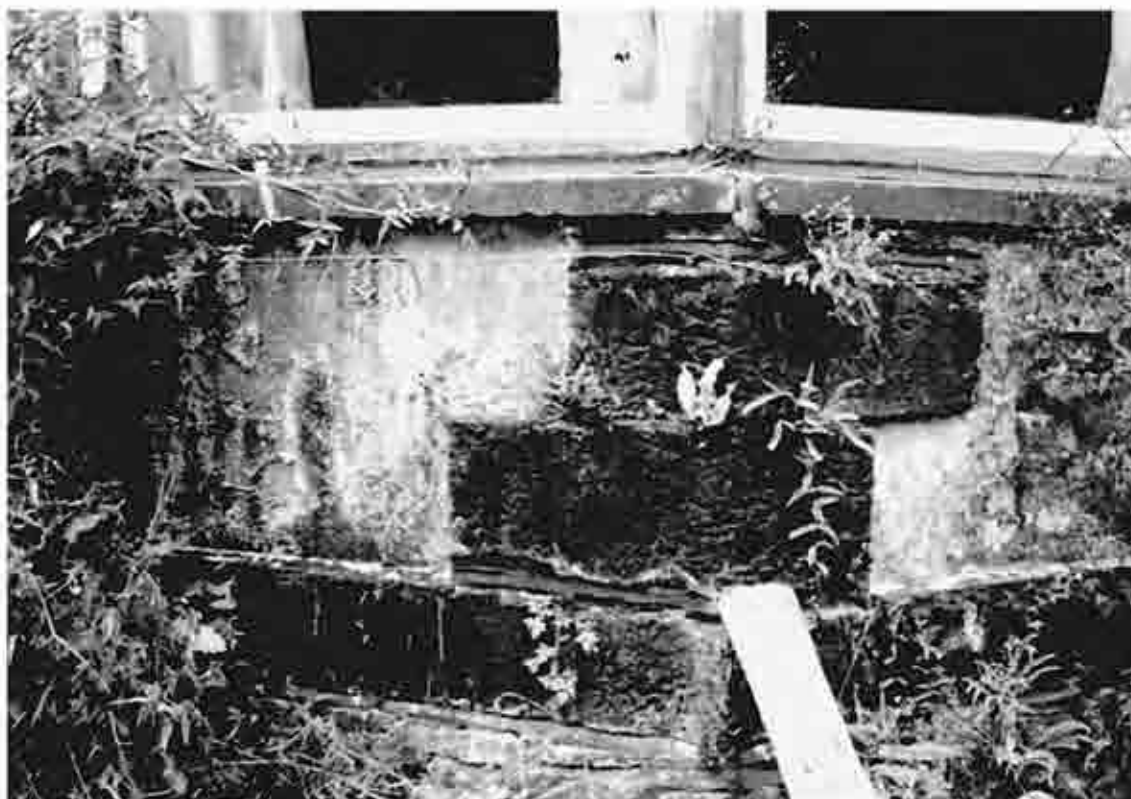
Figure 12. Angle-ended, bay type rectangular copper slag blocks at Highbury Farm, Redbrook, Newland

Highbury Farm was the only location to yield angle-ended quoins suitable, as used there, for bay windows (Figure 12). The blocks were 230mm wide, 230mm high and 470mm long to the line of change beyond which the block face continued diagonally for 255mm .

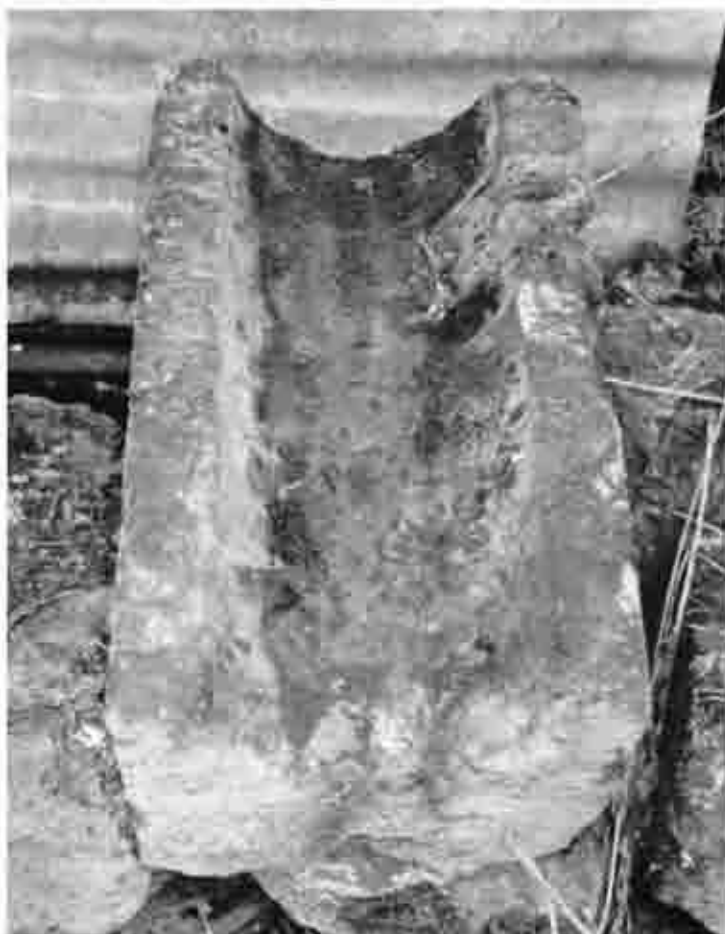
Figure 13. Copper slag channel block at Mill House, Lower Framilode, Fretherne-with-Saul

At three locations examples of channel blocks were found. They were around 440mm long, 200mm or 230mm wide and of differing heights between 152mm and 225mm They had either a 50mm or a 75mm radius channel running along the cast base (Figure 13). They would have been used rough top downwards; alternatively it may have been possible to use such blocks, one above another with channels facing each other, in land drainage. None of these blocks were *in-situ*. They did not occur at Redbrook but nor have they been noted as products of Bristol (or Swansea).
