EIGHTEENTH CENTURY SLAG CONSTRUCTION BLOCKS IN GLOUCESTERSHIRE - A SURVEY

Nigel Spry

From 1996, members of the Gloucestershire Society for Industrial Archaeology, the Gloucester and District Archaeological Research Group, the Forest of Dean Local History Society and the Bristol and Gloucestershire Archaeological Society, together with other fieldworkers, have undertaken a systematic survey of the locations and use of 18th century Slag Blocks in areas of the present county of Gloucestershire where they occur. This article explains the background to the subject, outlines the methodology of the survey and provides a summary of the results.

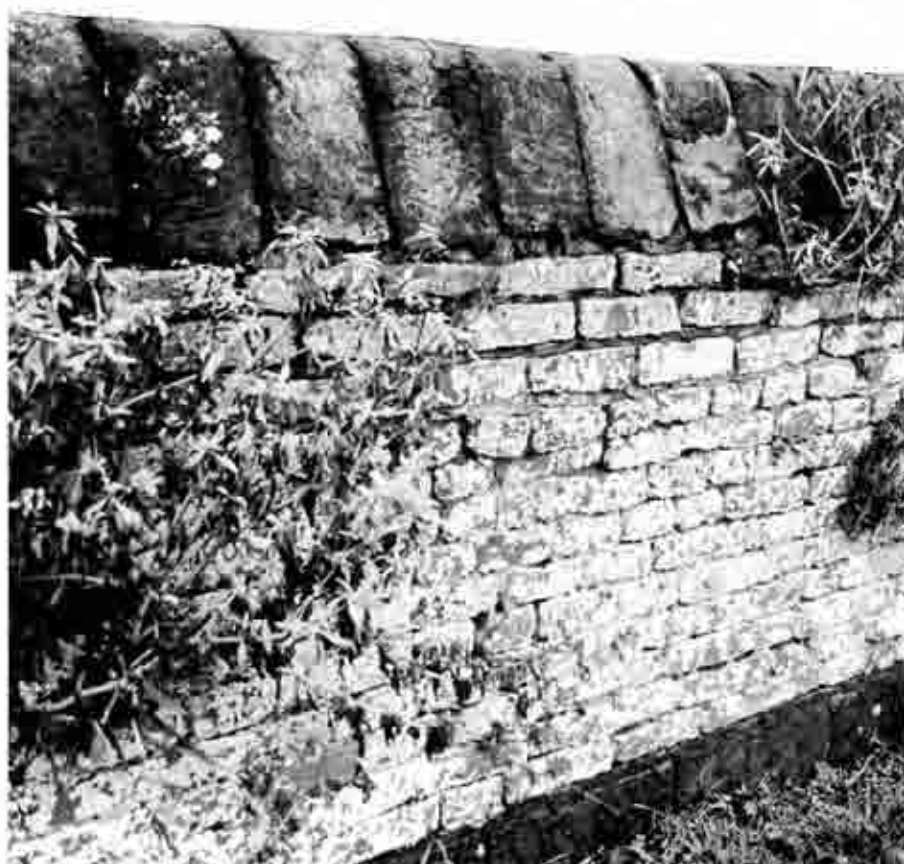
Figure 9. Triangular copper slag blocks used as wall copings at Nastend House, Nastend, Eastington,

Figure 8 shows the distribution of other block types. Triangular ones are used as wall copings (Figure 9) - one exception to this being a decorative insert at Corner House Farm, Corse. Triangular blocks seem mainly to have been cast vertically, thereby giving a rough top (wide end). Their height is variable from block to block, averaging about 355mm. Similarly, consequently, their width (at the wide end) can vary, within a 100mm range centred on about 375mm. As well as being found at the site of Lower Redbrook copperworks, examples of these blocks were noted on both sides of the Severn, though much more frequently on the east side, particularly around Berkeley. To the south of Berkeley, at Ham and Stone, a particularly interesting triangular block with a moulding mark was found amongst infill in front of a
