## EIGHTEENTH CENTURY SLAG CONSTRUCTION BLOCKS IN GLOUCESTERSHIRE - A SURVEY

Nigel Spry

*From 1996, members of the Gloucestershire Society for Industrial Archaeology, the Gloucester and District Archaeological Research Group, the Forest of Dean Local History Society and the Bristol and Gloucestershire Archaeological Society, together with other fieldworkers, have undertaken a systematic survey of the locations and use of 18th century Slag Blocks in areas of the present county of Gloucestershire where they occur. This article explains the background to the subject, outlines the methodology of the survey and provides a summary of the results.*

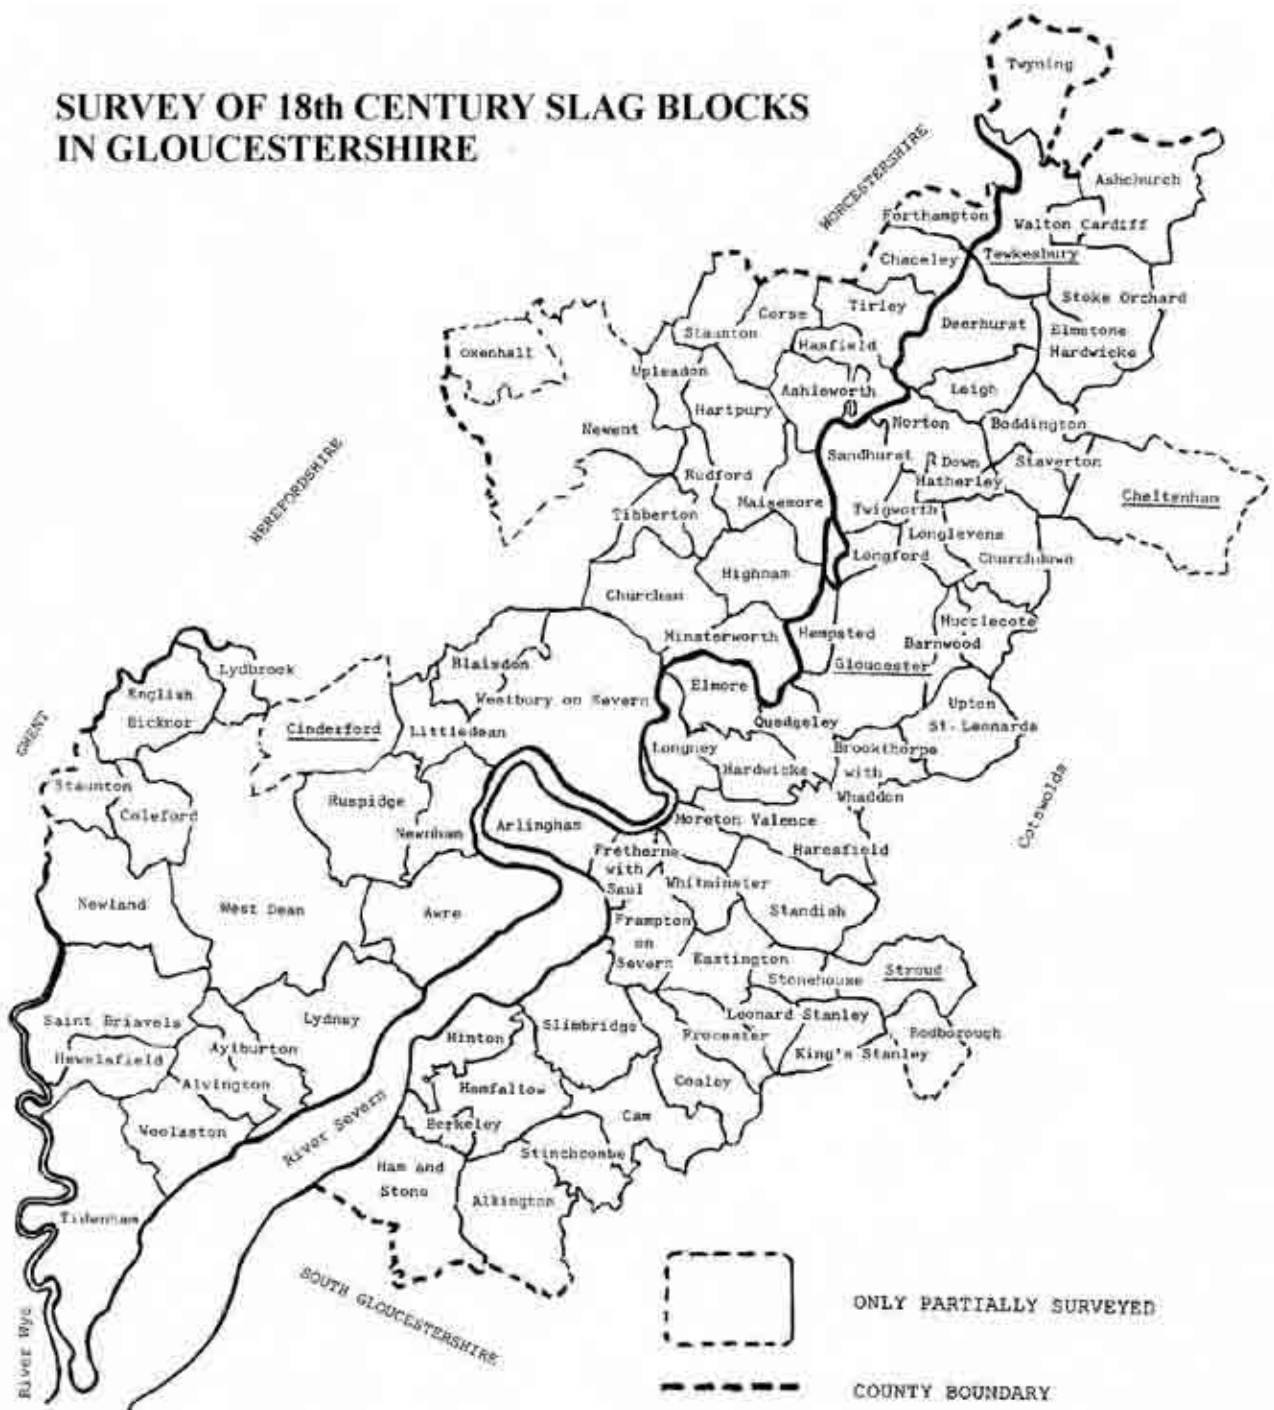
Figure 3. RIVERSIDE AND HINTERLAND PARISHES

The original ambitious intention was to record the slag blocks in all ‘pre-1974’ Gloucestershire parishes beside the Severn and Wye and in hinterland parishes one or two beyond the riverside ones, depending on the topography – these being areas where blocks are known to occur. Unfortunately it was not possible to find people to do the survey in South Gloucestershire, so ultimately only the area of the present-day county has been investigated (Figure 3). Parishes were assigned to fieldworkers on the basis of familiarity and accessibility. Recording west of the Severn was undertaken by the Forest of Dean Local History Society and initially reported (53) and then published by them.(54) Particularly in the north of this area, work was either shared with or done by the Gloucester and District Archaeological Research Group, whose members also undertook recording in Vale parishes. With the exception of parts of Cinderford, Oxenhall, Newent, Cheltenham and Rodborough, all peripheral to the main slag block distribution, the area shown in Figure 3 has been fully investigated, but in some cases without success. For practical reasons the whole of Upper Redbrook was treated as though in Newland, Gloucestershire
