REMNANTS OF NEWENT FURNACE

D. E. BICK

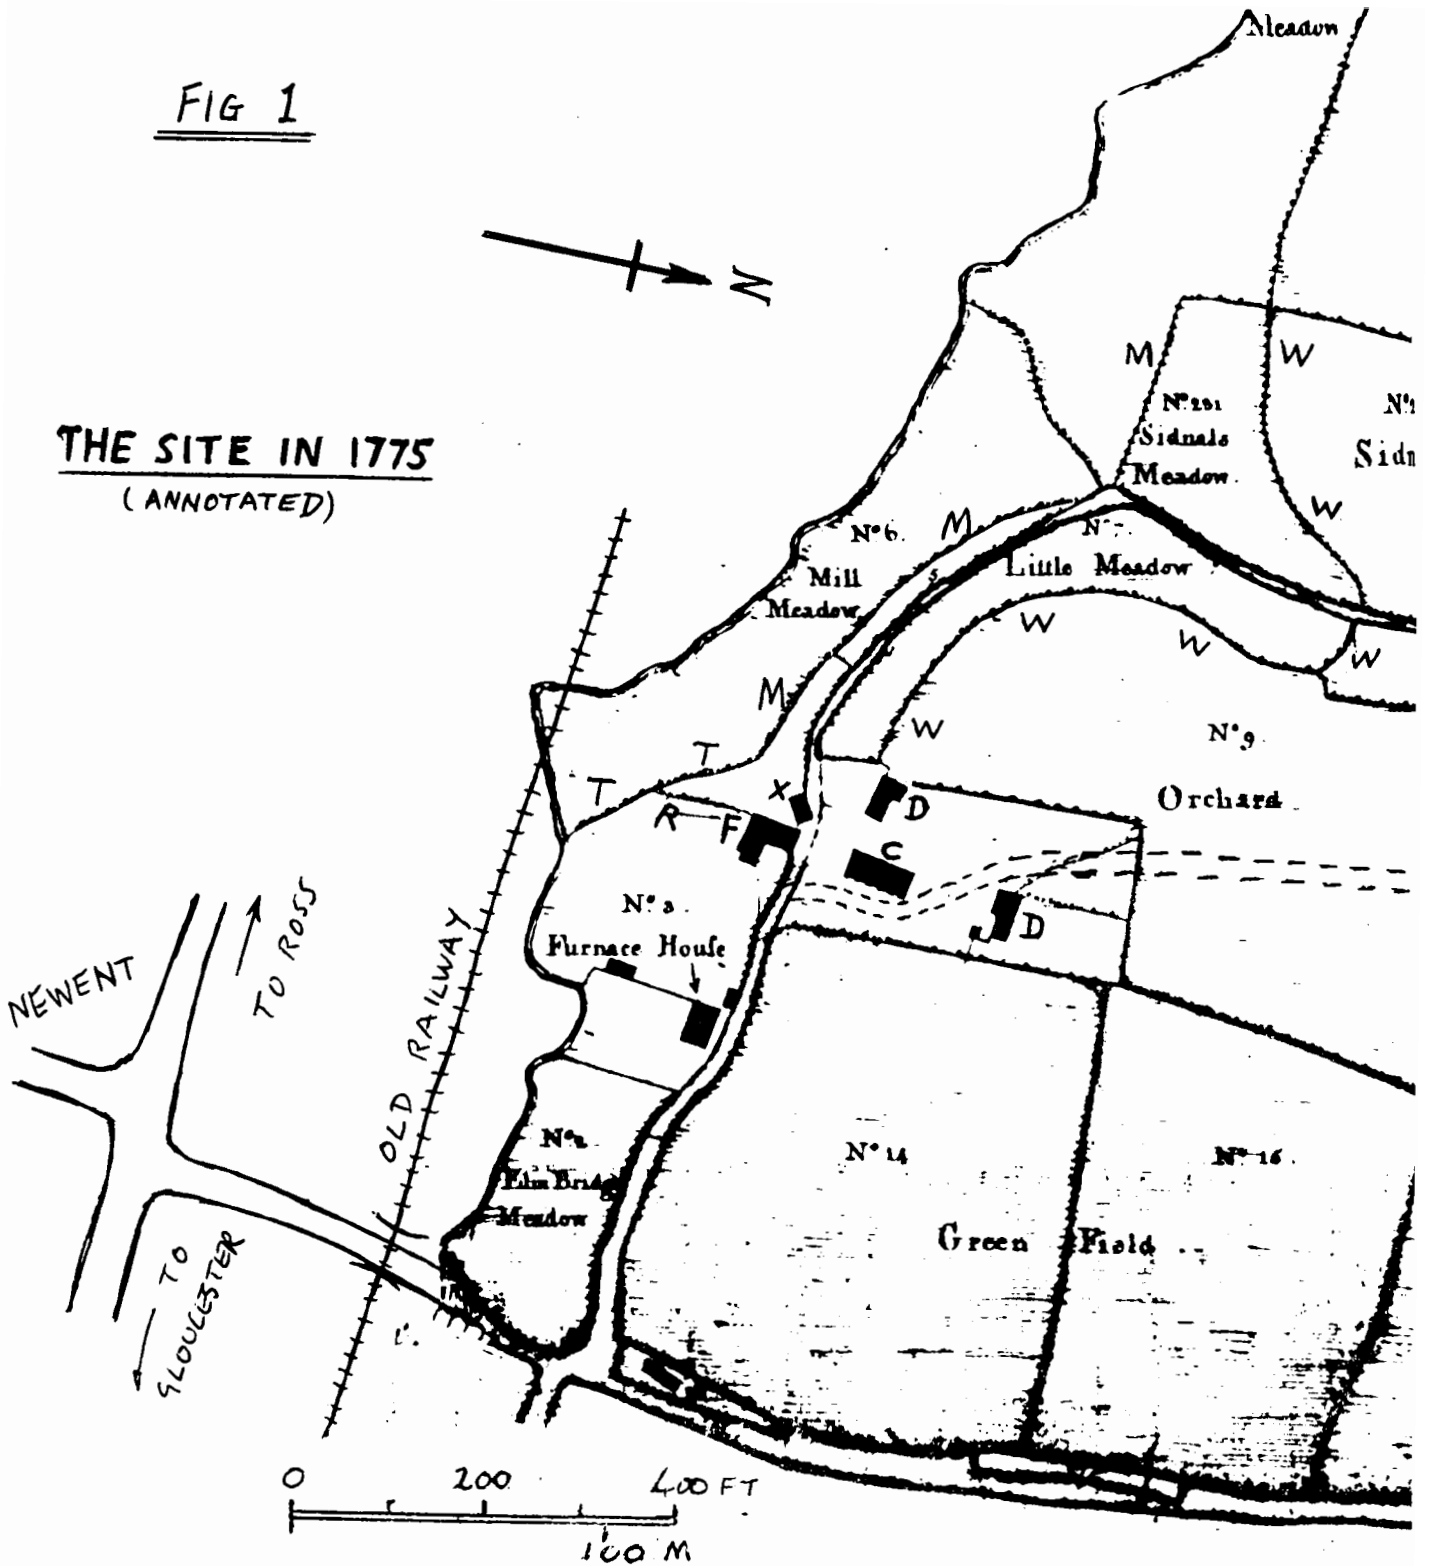
FIG 1

The earliest plan or map (6) so far discovered (Fig.1) is dated 1775, to a scale of 3 chains/inch. At such a date we might expect the furnace to be shown, especially bearing in mind Rudder's implication of its existence when he wrote. Unfortunately the scale is small, and by comparison with buildings in the area still extant, errors come to light. The charcoal store C scales 68ft x 28ft, compared to approximate actual dimensions of 75ft x 34ft i.e., 10% low on the longer side, and more on the shorter.

THE SITE IN 1775
(ANNOTATED)

The two buildings D,D, doubtless featured in the 1749 inventory. The L shaped building which now occupies the supposed site or close proximity of the furnace has given rise to speculation, and is the main concern of this account. Examination reveals major modifications, some carried out perhaps two centuries ago, presumably to convert for farm purposes. Additions to the

An unresolved question is whether or not the building is the same as the L shaped representation F on the 1775 plan. On casual scrutiny there could be little doubt, but on scaling the dimensions a much longer structure in the north-south axis is indicated. However, in view of the unreliable nature of the plan, it is safe only to deduce from this evidence alone, a strong probability rather than a certainty that the 1775 building was substantially longer than now. That we are talking of basically the same structure would seem definite, considering its obvious antiquity.

In one respect, the 1775 plan is an embarrassment. The yard is not shown, but instead there is a small building X, which occupies a situation seemingly straddling the 15 ft retaining wall. This is quite unaccountable unless the yard is post-1775, which seems unlikely in view of its relationship with the west wall.

Towards an understanding of the site, the height at which the water for the wheel entered is important to be ascertained. I have assumed the watercourse followed the sinuous field boundary W on the 1775 plan, and think this is virtually certain. The level corresponds more or less with the 35 metre contour and the top of the retaining wall. The fact that there is no opening in this wall may be taken as evidence that the launder, if it came into the yard area, did so at this level, at least.

Further clues are on the 1775 plan (Fig.1). There is marked "Mill Meadow", and the field boundary M running parallel to the watercourse W is highly suspicious, although the significance did not strike me until this account was virtually completed. The boundary could denote the original mill leat; it is just where it would be expected and offers to explain the peculiar thin slice of land between Mill Meadow and the lane. (This part of the lane was abandoned before 1842, it subsequently taking the route shown by the dotted lines on Fig.1).

On the ground we find definite evidence of the leat, 6 ft wide in one place, on a ridge or shelf of land extending about 100 yds in length. There are also possible traces 450- 550 yds west of building F, just above the brook. TT or TR being on a low level, could denote the tail-race. If the former, the corn-mill and hence the furnace stood at the intersection of TT and MM. This would also account for the field boundary (watercourse) W turning south at its end, but offers no solution to the building X, hanging so to speak, in mid-air (see under West Elevation). The theory is not without attraction, but if valid, means that not a trace of the furnace now remains, unless part of the mill did extend to include the building F.

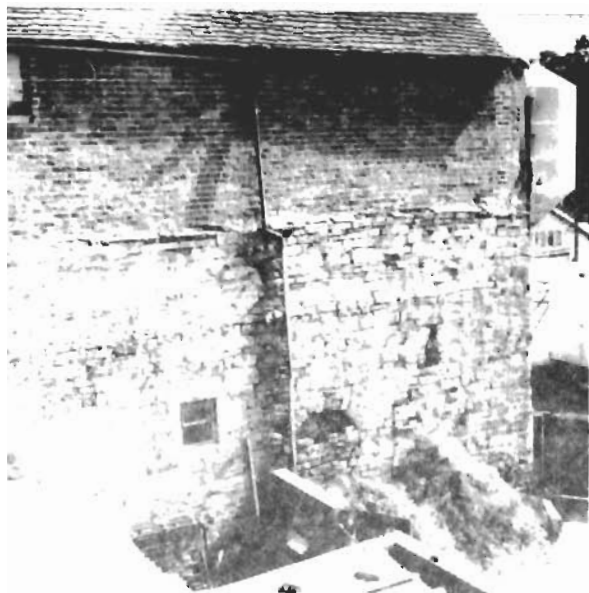
1

1. The main building 1972. Note circular walled-up hole, perhaps for the waterwheel axle.

A buttress reaches to the ceiling with a pronounced batter in the south-west corner, and serves no purpose in the present structure. In the west wall faintly can be discerned an infilled aperture about 5 ft square without a lintel, also a circular hole nearly 4 ft diameter, which from the outside appears contemporary with the wall. There is a parallel buttress between the two, cut away in a segment to maintain the integrity of the hole. The timber flooring of the room above totals about 2 ft thick.

The square and circular holes previously mentioned are low down at the southern end, and are largely obscured by building materials etc. There are signs of other apertures in this wall, now filled in.

The top of the retaining wall is nearly 11 ft above the centre of the circular hole, which might be supposed accommodated the bellows waterwheel axle. If so, a wheel diameter of 20 or 21 ft is implied, which is in the same order as the practice at Parkend, Cannop and Lydbrook furnaces, all built or re-built about the same time (1630s) with wheels of 22 or 23 ft (10).

Another important dimension is the level of the Ell Brook into which the tail-race discharged. According to a Dumpy-Level survey just carried out, the centreline of the circular hole is $15\frac{1}{2}$ ft above water level. This is ample for a 20 ft diameter wheel, except perhaps in time of heavy flood. It would be interesting to know how other furnace sites compare in this respect.

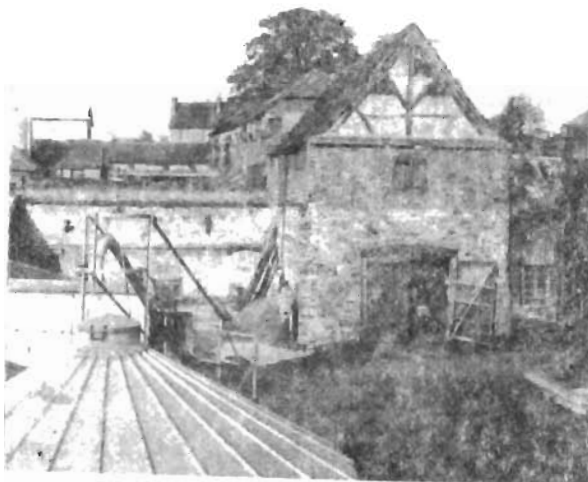
2

2. The main building and yard, charcoal store partially obscured.

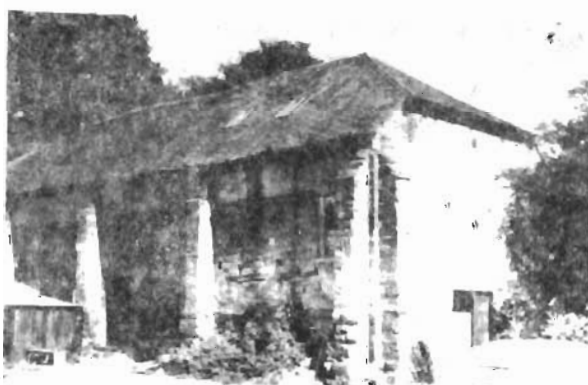
3

3. The charcoal store from the south-west, 1972.

This splendid building is now in a delapidated condition. It is built of red sandstone, Downton sandstone and brick. The floor slopes, and its lower or exit end is several feet above the floor of the main building, upper storey.

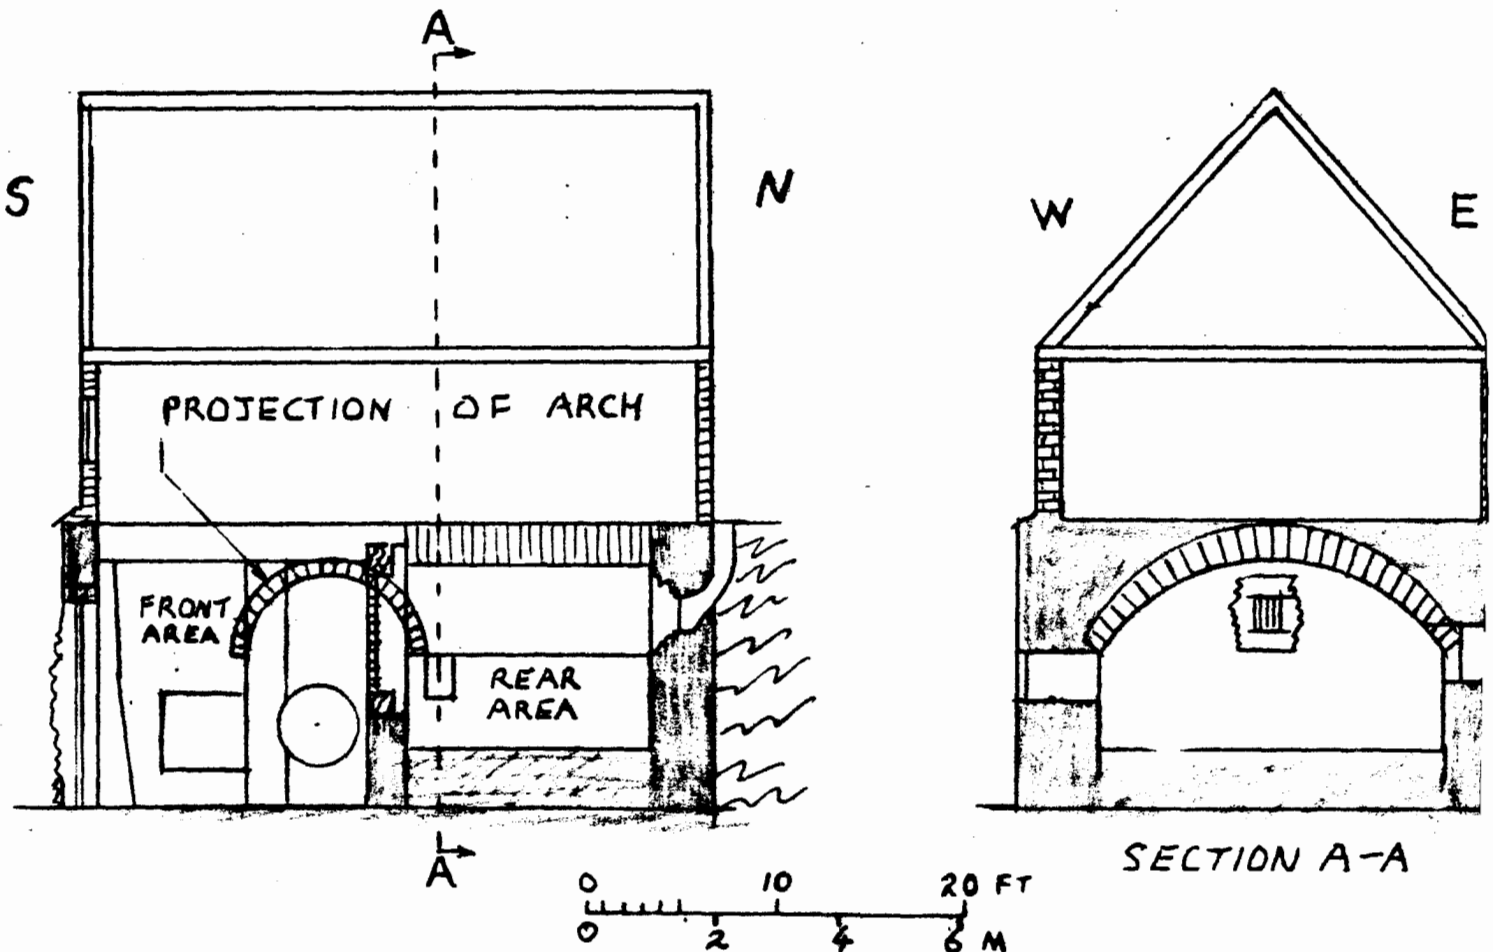
FIG 3 SECTIONS THROUGH MAIN BUILDING

As can be gathered from Figs. 2 and 3, the ground floor of the main section is divided into two areas, the front (south) and the rear (9).

The eastern wall is almost 3 ft thick to a height of some 8 ft, then reducing by a step and revealing part of a fine circular arch. The remainder of this arch is seen from the rear area, to which it gives access from the wing. The arch is of a higher standard than the rest of the stonework. Two feet above the floor below the arch is a shelf or platform of stone, the length and extent of which cannot be gauged due to later brickwork and a higher level of floor on the other side. This shelf could have significance in relation to the circular hole opposite. (see later).

This comprises a kind of cellar vault with brick roof of a type encountered in basements of old houses. The walls are several feet thick and it appears that each has been cut through to provide a window. Examination of the apertures so formed suggests that the arch is contemporary with the walls, and this is borne out by the manner in which the brickwork is carefully blended into the masonry associated with the arch. Nevertheless, there is a lingering doubt - see under the next paragraph. It is suspicious that the inner end of the vault is butted up against a stone wall, which itself stands proud of the parallel retaining wall outside. The stone wall contains a vent that comes out in the floor of a shed on the northern end of the upper storey. This may be a later addition.

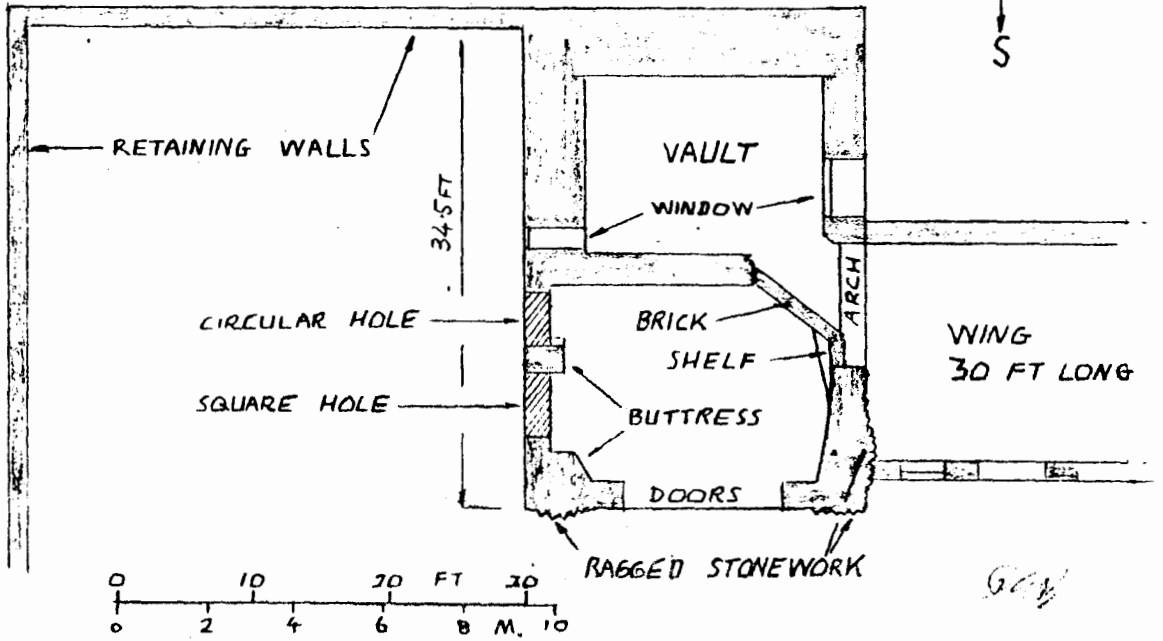
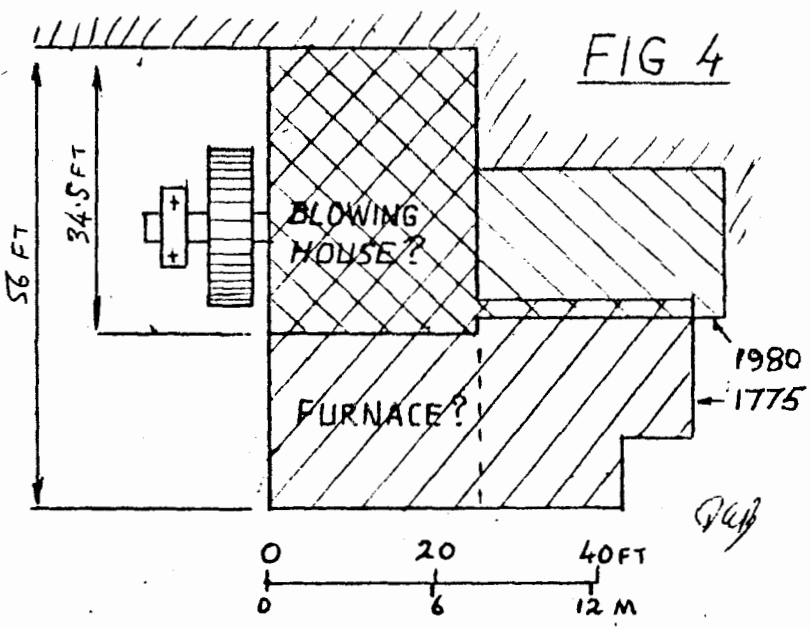
FIG 2

The conjectured layout is shown in Fig.4. It includes the present ground plan, and the 1775 outline which has been scaled up by 8% so that the widths co-incide, as they must. (We have already seen that this adjustment is in the same order as that necessary to correct the charcoal store). The overall length of

PLAN OF SITE

The overall length of the main building then proves to be 56 ft, or 21.5 ft longer than at present.

Turning now to the tentative hypothesis expressed earlier, if the furnace stood immediately against the southern end of the present building, the front area could have housed the bellows, with the twyers being just outside the site of the double-doors, and the wheel alongside the west wall (12). However, it could be argued that this wall bears no tell-tale witness of a wheel, such as water erosion or circular scratches often encountered elsewhere. Perhaps the wheel stood a little distance away. The casting shed could have occupied the wing on the 1775 plan though it appears rather small for the purpose. A timber roof to the front area is in keeping with timber bridges at Cannop, Lydbrook and Parkend (10).

In the front area, the shelf on the eastern side might have taken the cam-axle pedestal bearing. The proximity of the masonry wall (dividing wall) is difficult to explain, leaving little clearance for the axle and cams. Perhaps it supported the lever fulcrums. However, this configuration fails to explain the ragged wall on the east side, and the arch.
