KILCOTT MILL RESTORED

W. G. MEDLAM.

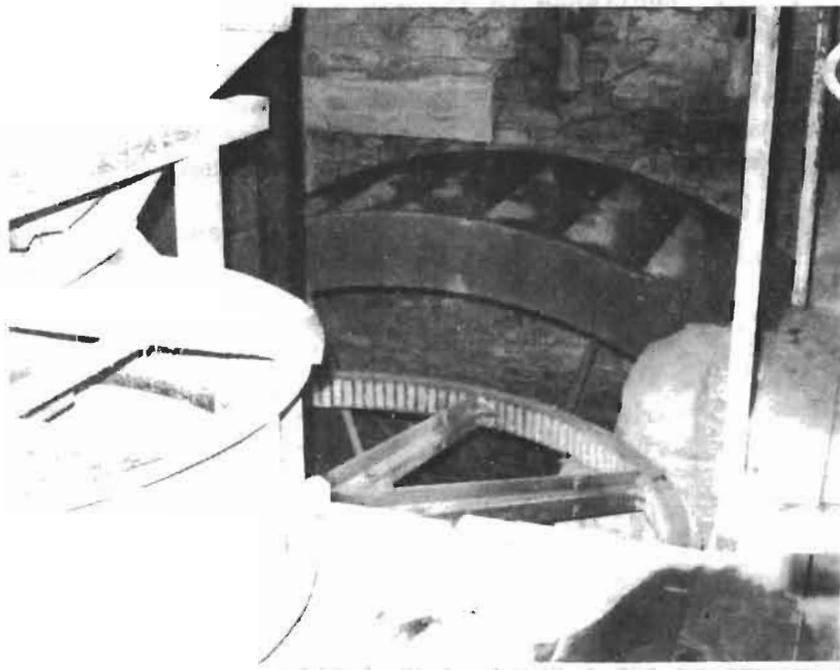
General view of the water-wheel driving the horizontal spur wheel which turns the upper grinding stone

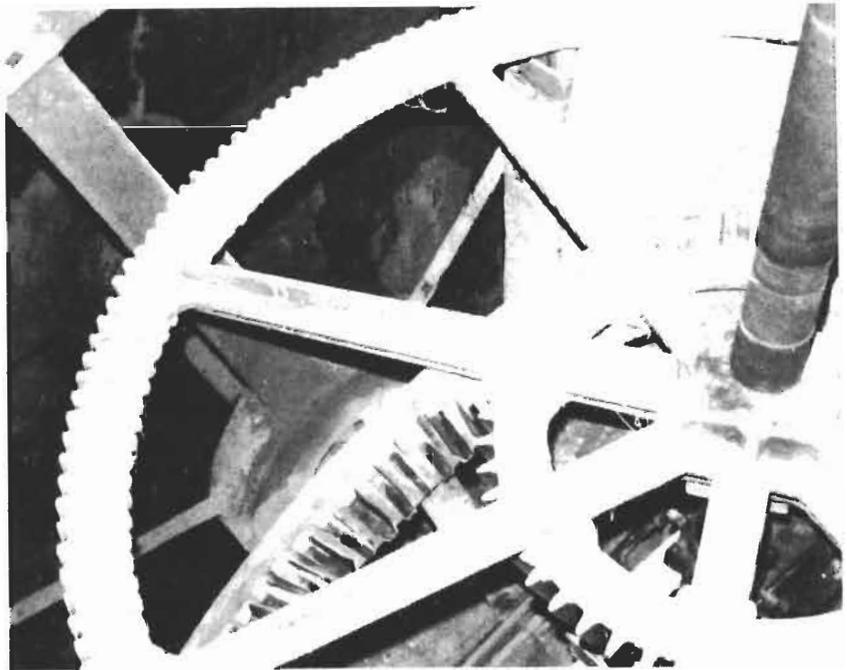
Downward view of the wallower wheel which drives the vertical power shaft to which spur wheels on each floor are attached. The view also shows the water-wheel in the background.

At the time of restoration, the pitwheel packing on the axle had decayed and the pitwheel was leaning drunkenly against a not too stable crumbling stone wall. Undismayed, the engineer and millwright hung the wheel from a roof truss at the top of the mill and with eight small jacks specially constructed for the purpose, at some considerable trouble and expense repacked the centre of the pitwheel with wood and adjusted it to perfect engagement with the wallower wheel.

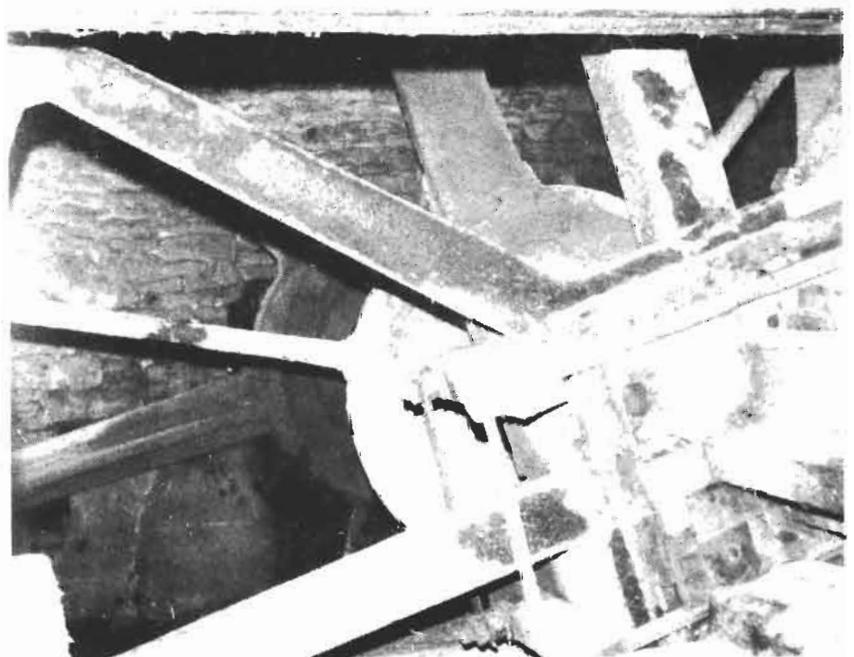
Thereafter the troubles have mostly been ones of repair and maintenance. New floorboards, gutter clearing, repairs to ladders, hurstings, meal spouts and such like. The biggest repair was to the pit wheel: originally it had been constructed in two halves then bolted together onto the driving axle connecting the pitwheel with the water wheel. Sometime in the past it had suffered damage and was no longer fully true. This caused it to move along the connecting axle which in turn moved it out of comfortable engagement with the wallower. As a result the central packing box was strained, causing the corners to open and so put the whole pitwheel out of true.

The central box of the pitwheel strained at the corners, now strapped together. Also shown is the renewed wood packing round the axle.

Immediately the mill engineer and millwright designed a bracing bracket which in the event proved not strong enough to retain the strain. This defect was quickly observed and further bracing bars and rods were designed. After templates, first of wood then of mild steel, had been tested, proper braces and bars were cast and installed, and the trouble overcome.
