## EIGHTEENTH CENTURY SLAG CONSTRUCTION BLOCKS IN GLOUCESTERSHIRE - A SURVEY

Nigel Spry

*From 1996, members of the Gloucestershire Society for Industrial Archaeology, the Gloucester and District Archaeological Research Group, the Forest of Dean Local History Society and the Bristol and Gloucestershire Archaeological Society, together with other fieldworkers, have undertaken a systematic survey of the locations and use of 18th century Slag Blocks in areas of the present county of Gloucestershire where they occur. This article explains the background to the subject, outlines the methodology of the survey and provides a summary of the results.*

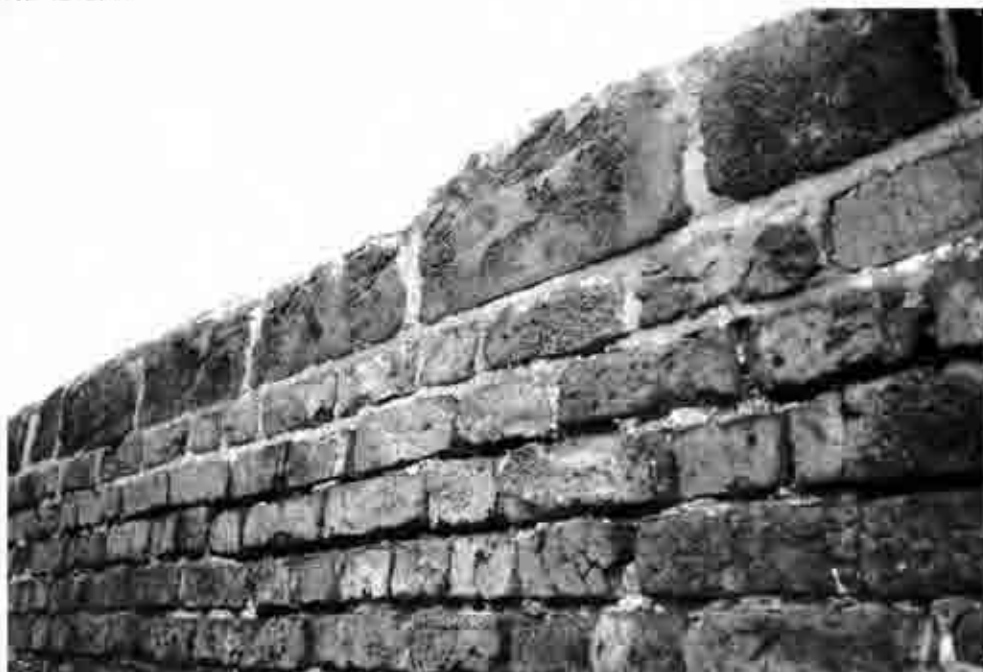
Figure 1. Rectangular copper slag blocks used as copings on a wall beside Organ's Alley, Gloucester

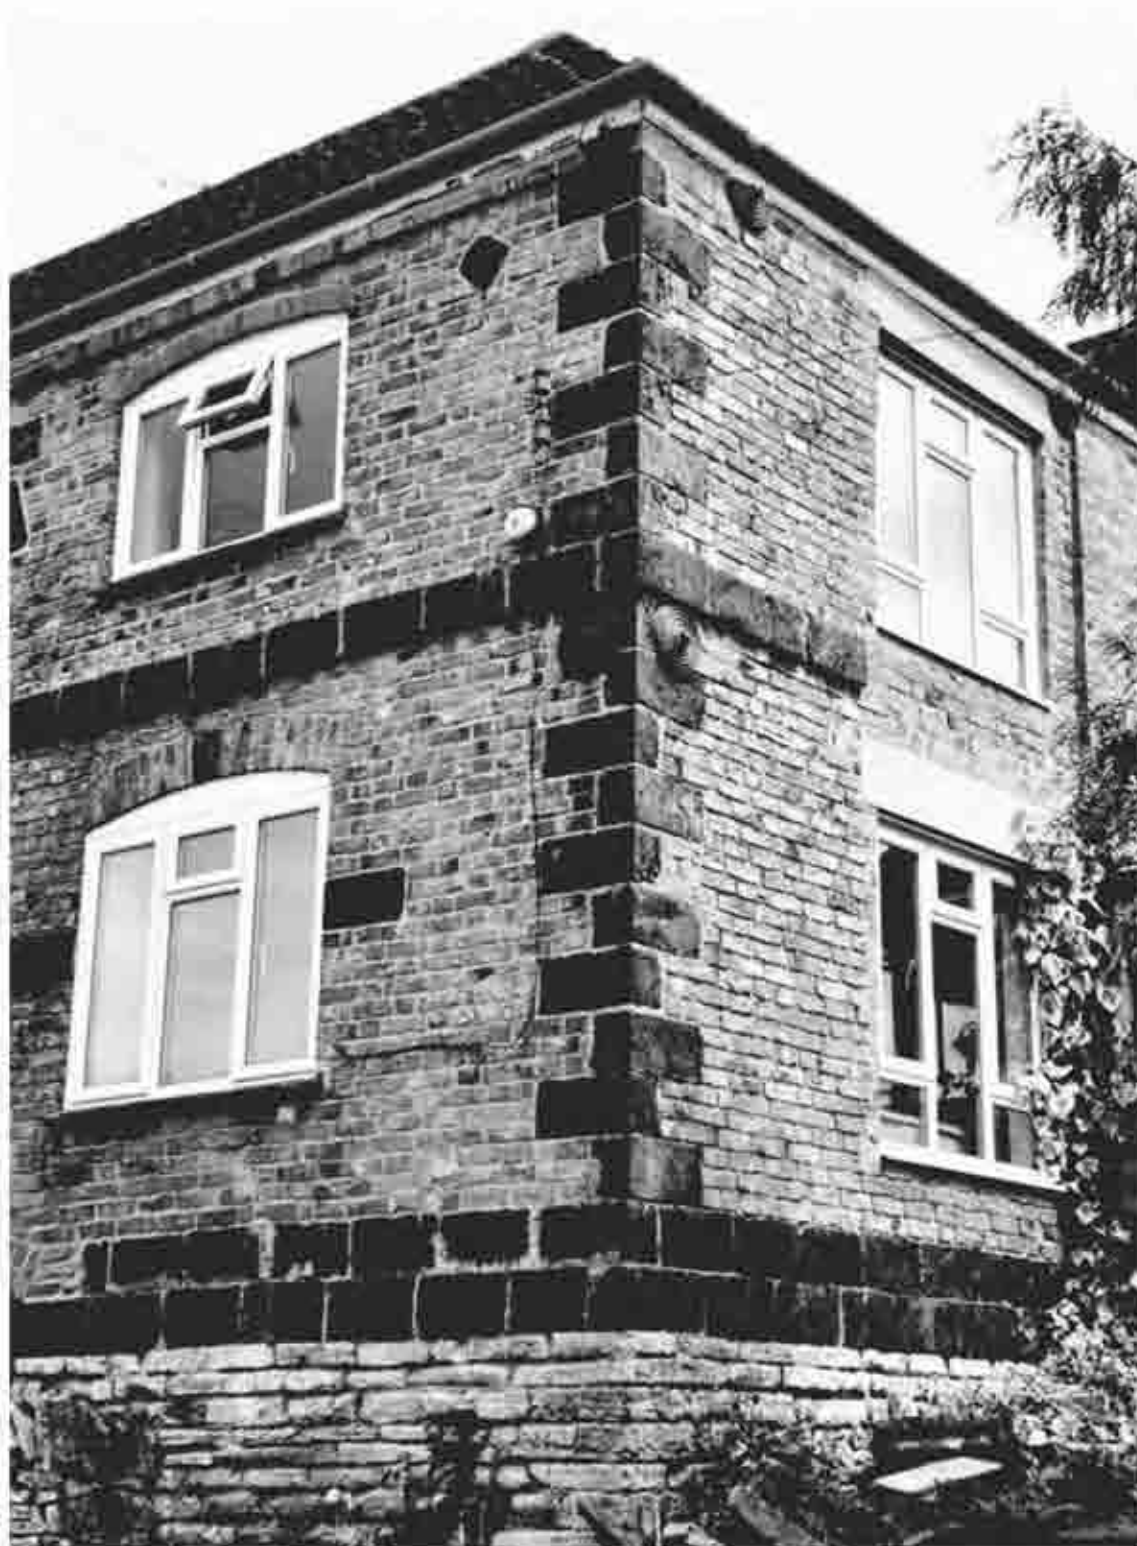
Figure 7. Use made of slag blocks at Corner House Farm, Corse

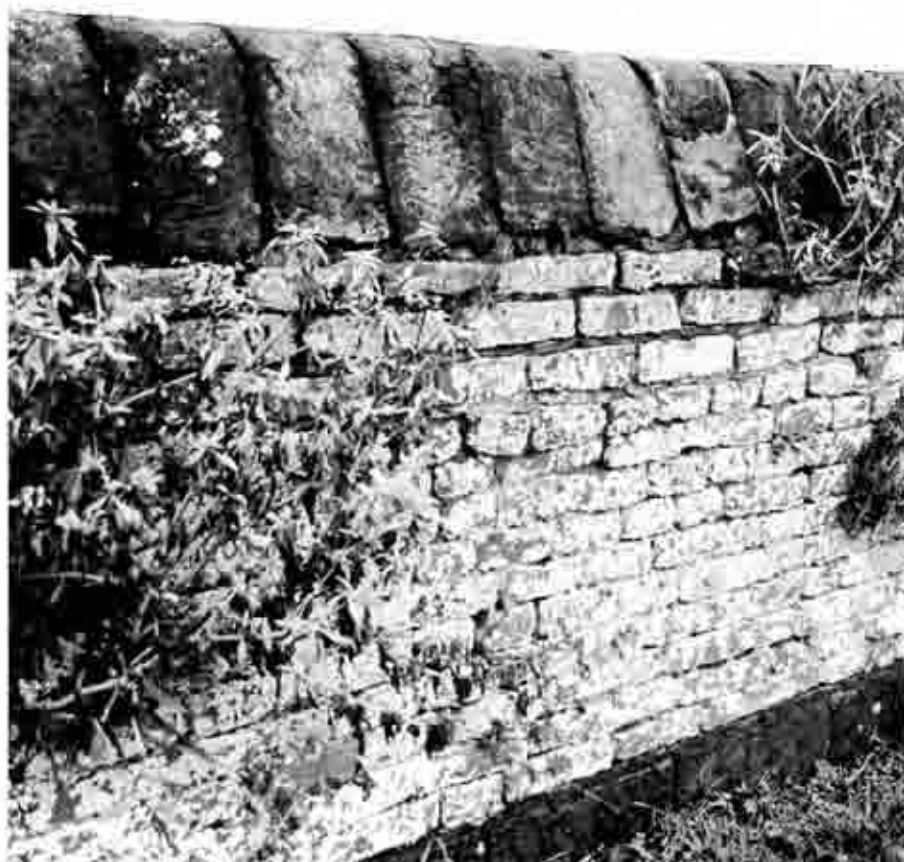
Figure 9. Triangular copper slag blocks used as wall copings at Nastend House, Nastend, Eastington,

Figure 8 shows the distribution of other block types. Triangular ones are used as wall copings (Figure 9) - one exception to this being a decorative insert at Corner House Farm, Corse. Triangular blocks seem mainly to have been cast vertically, thereby giving a rough top (wide end). Their height is variable from block to block, averaging about 355mm. Similarly, consequently, their width (at the wide end) can vary, within a 100mm range centred on about 375mm. As well as being found at the site of Lower Redbrook copperworks, examples of these blocks were noted on both sides of the Severn, though much more frequently on the east side, particularly around Berkeley. To the south of Berkeley, at Ham and Stone, a particularly interesting triangular block with a moulding mark was found amongst infill in front of a

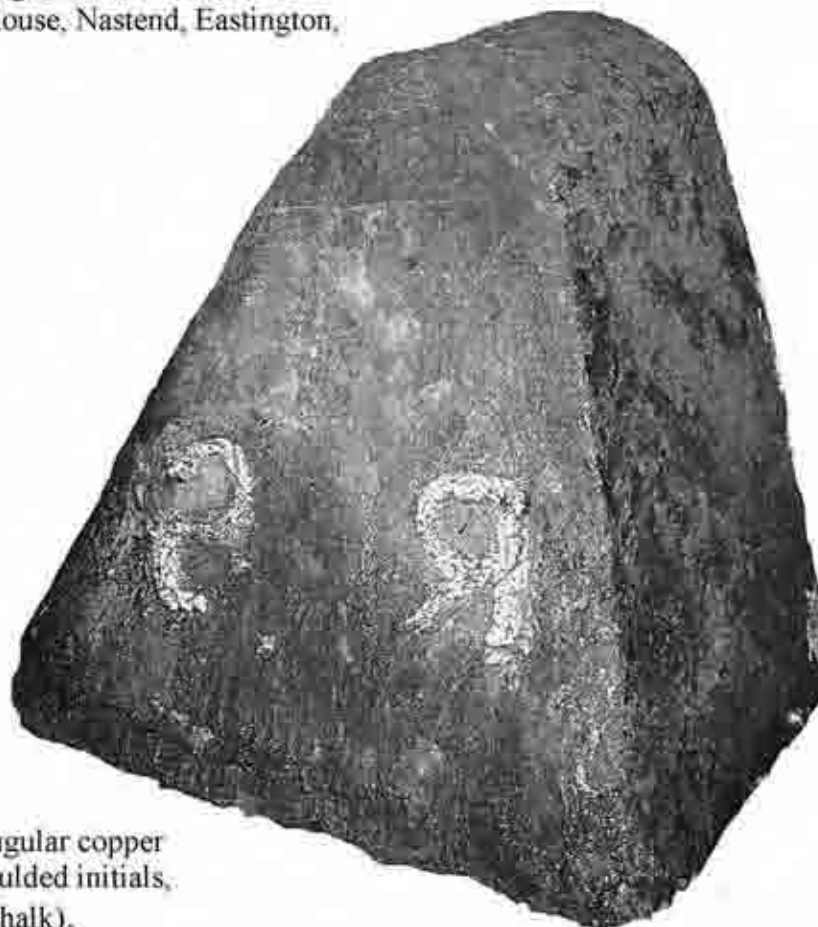
Figure 10. Non-standard triangular copper slag block with moulded initials, (highlighted with chalk), recovered from Ham and Stone.

trackway gate west of Whitecliffe Park (Figure 10). Reversed R and S are clearly shown in relief, these letters originally having been depressed in a vertically tapering mould set unspaced side-by-side (co-joined) with a standard triangular one prior to casting. It seems likely that the block was used, or intended, as a property or field boundary (mere) stone. This is the only known local example of a mould mark, but Stephen Hughes quoted Roman numerals on rectangular blocks used as wall copings at one site in South Wales.(56) Double-length triangular blocks, from co-joined regular moulds were recorded at Redbrook including on the Lower Redbrook copperworks site, but nowhere else.

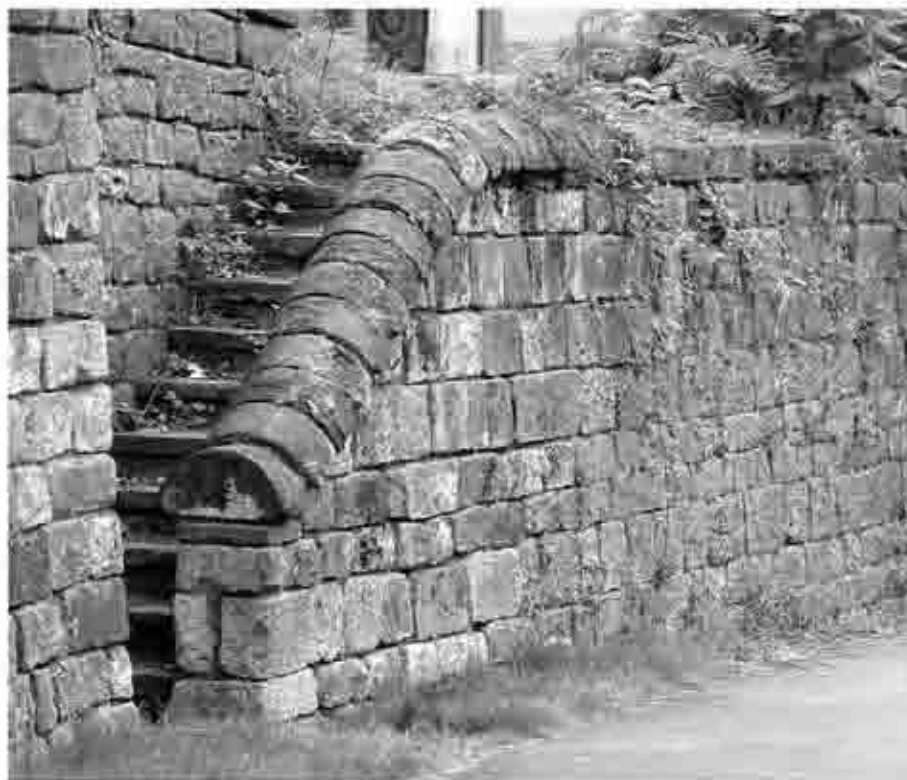
Figure 11. Half-round copper slag blocks being reused at Lower Redbrook

Half round wall coping blocks (Figure 11) are less common, being found at eleven locations, all to the west of the Severn, including at the Lower Redbrook copperworks and nearby Highbury Farm, Newland where they formed caps on a crenellated facade. Their average dimensions are 220mm high, 435mm wide and 205mm long. Such blocks were also used to make a column at Hill House, Newnham-on-Severn. Larger half round blocks were employed to construct the columns supporting the first floor of the warehouse at Newnham quay. These blocks are 305mm high (though used flat), 615mm wide and 200mm long. Large half-round blocks, though apparently shallower, also topped part of the Highbury Farm facade.

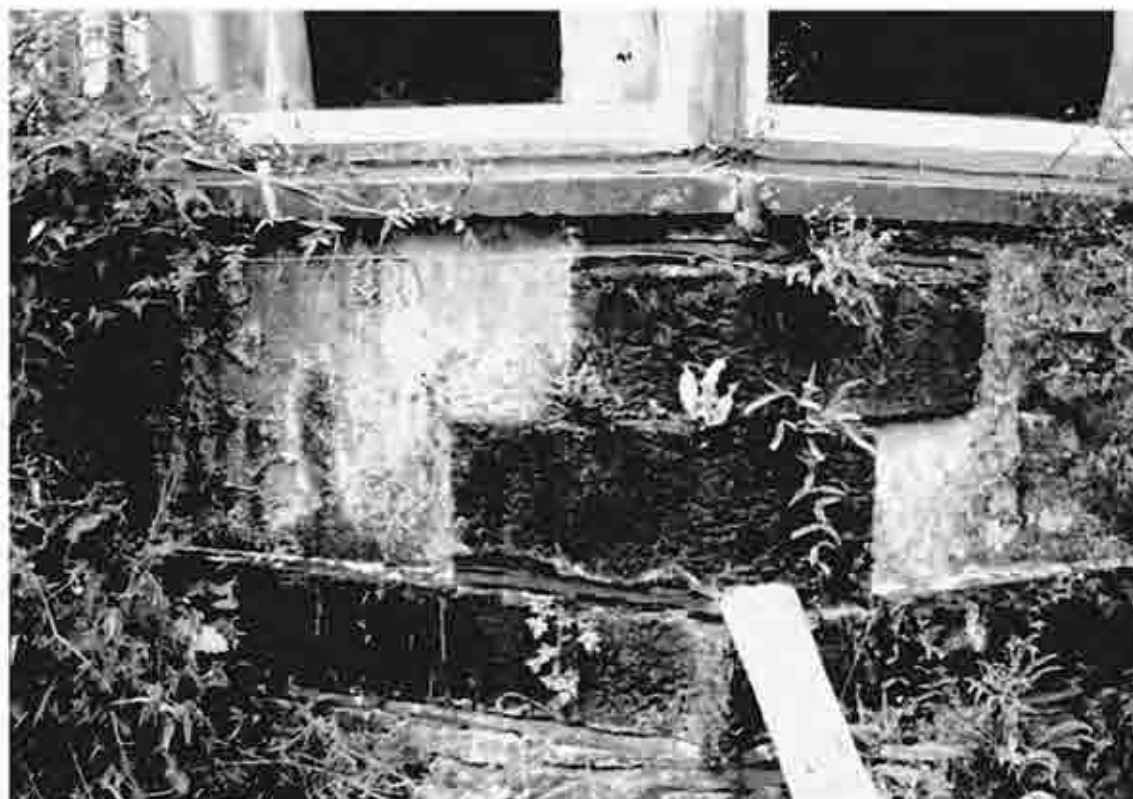
Figure 12. Angle-ended, bay type rectangular copper slag blocks at Highbury Farm, Redbrook, Newland

Highbury Farm was the only location to yield angle-ended quoins suitable, as used there, for bay windows (Figure 12). The blocks were 230mm wide, 230mm high and 470mm long to the line of change beyond which the block face continued diagonally for 255mm .

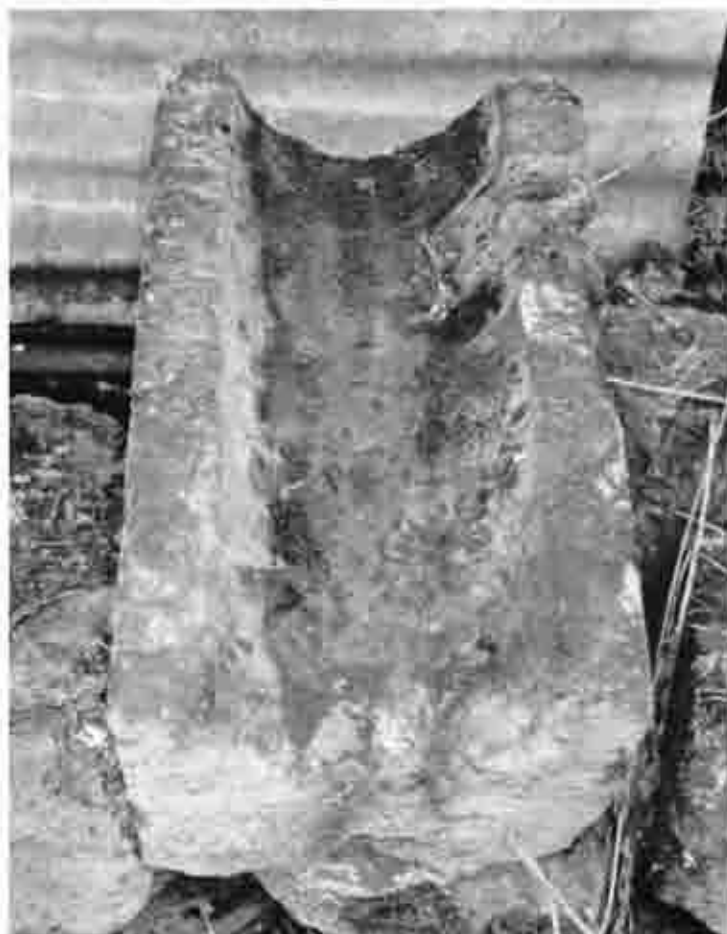
Figure 13. Copper slag channel block at Mill House, Lower Framilode, Fretherne-with-Saul

At three locations examples of channel blocks were found. They were around 440mm long, 200mm or 230mm wide and of differing heights between 152mm and 225mm They had either a 50mm or a 75mm radius channel running along the cast base (Figure 13). They would have been used rough top downwards; alternatively it may have been possible to use such blocks, one above another with channels facing each other, in land drainage. None of these blocks were *in-situ*. They did not occur at Redbrook but nor have they been noted as products of Bristol (or Swansea).

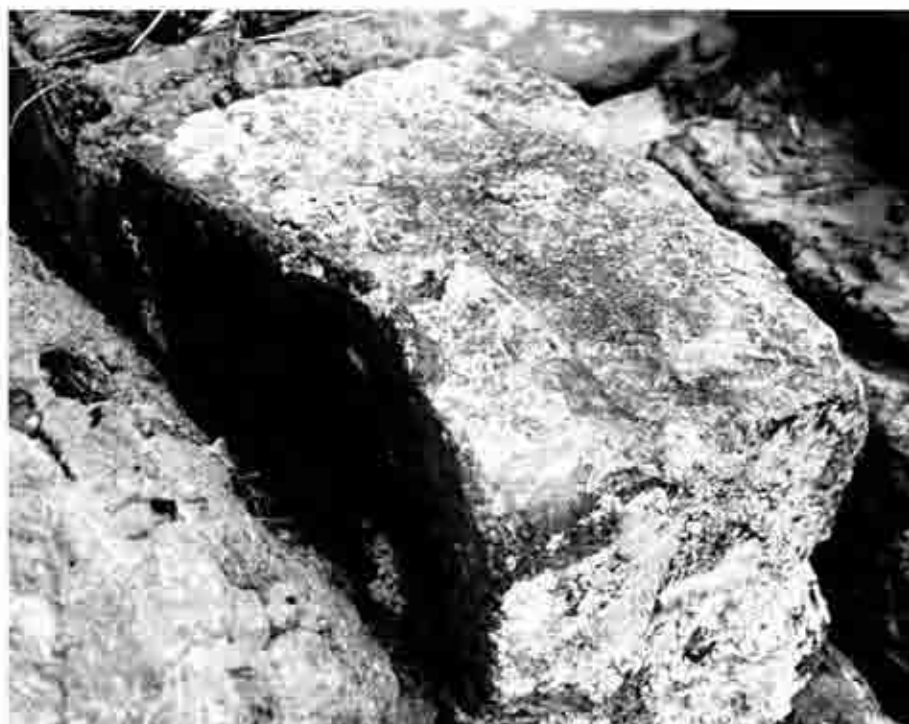
Figure 14. Depressed type rectangular slag block at Lower Redbrook copperworks site
